Site Visit Report

Project:	Project No.:	Date:	Reviewed by:	Weather:	Report No.:
OCSCC 982 - Balcony Rehabilitation	7597.06	May 14, 2026	M.Cogliati	--	39
Total Site Visits to Date:					67

Area of Review: Drop 13 ('17)

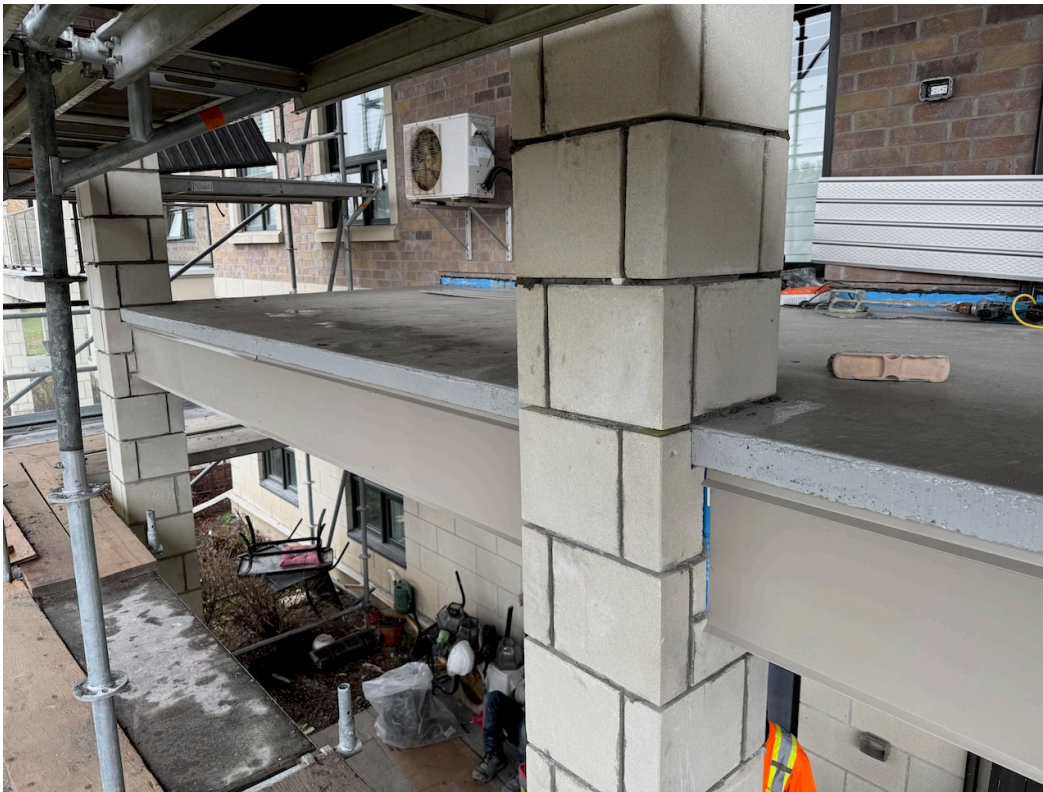
Photo 1: Drop 14 - April 30 - General view of the second floor balcony traffic topping, metal flashing, and masonry column cladding ongoing.

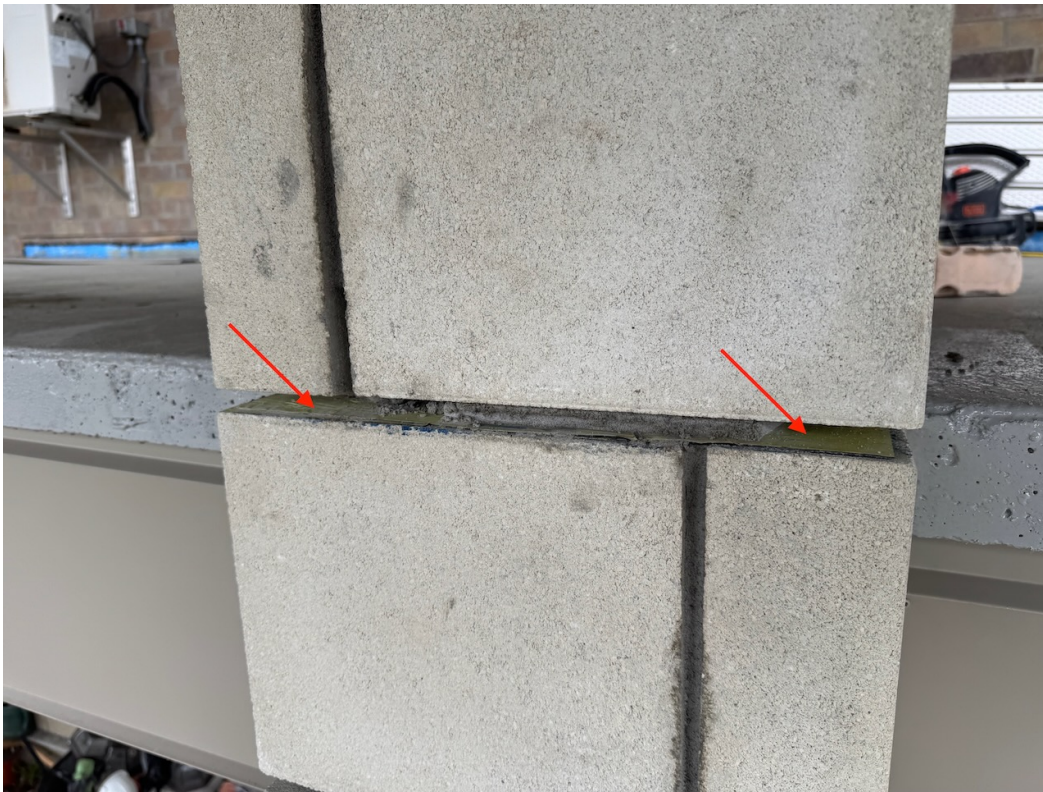
Photo 2: Blueskin TWF membrane installed at the balcony slab level through the masonry column cladding.

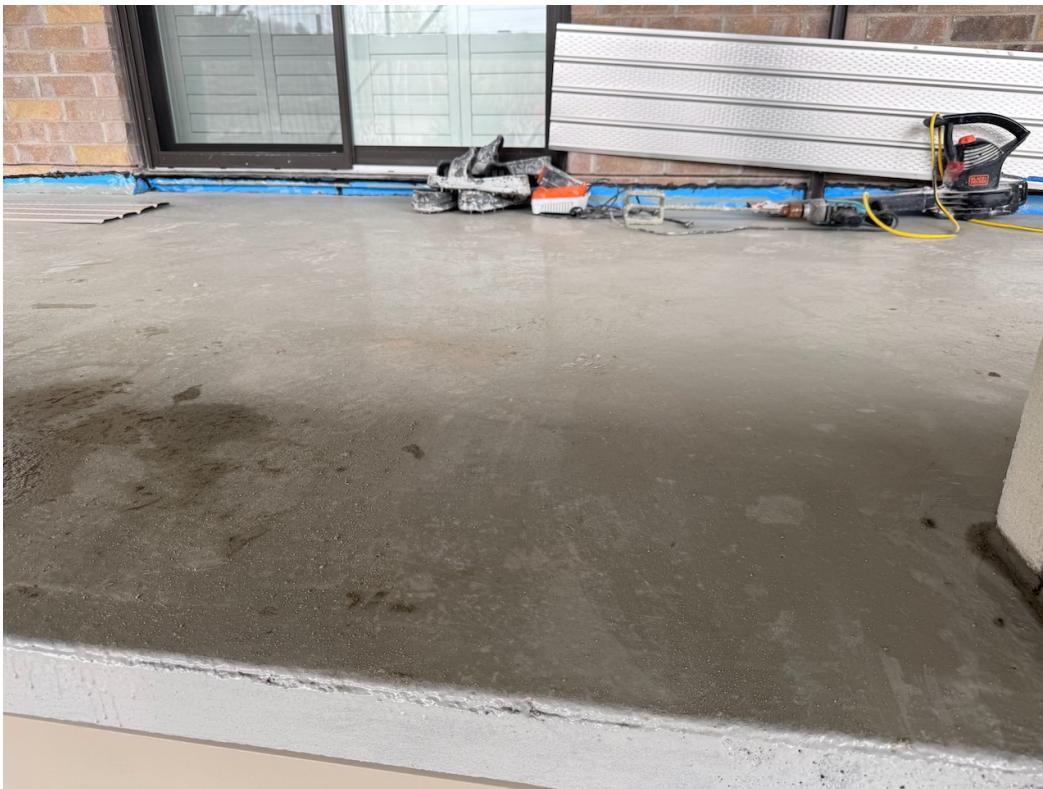
Photo 3: Base coat of the balcony traffic topping membrane.

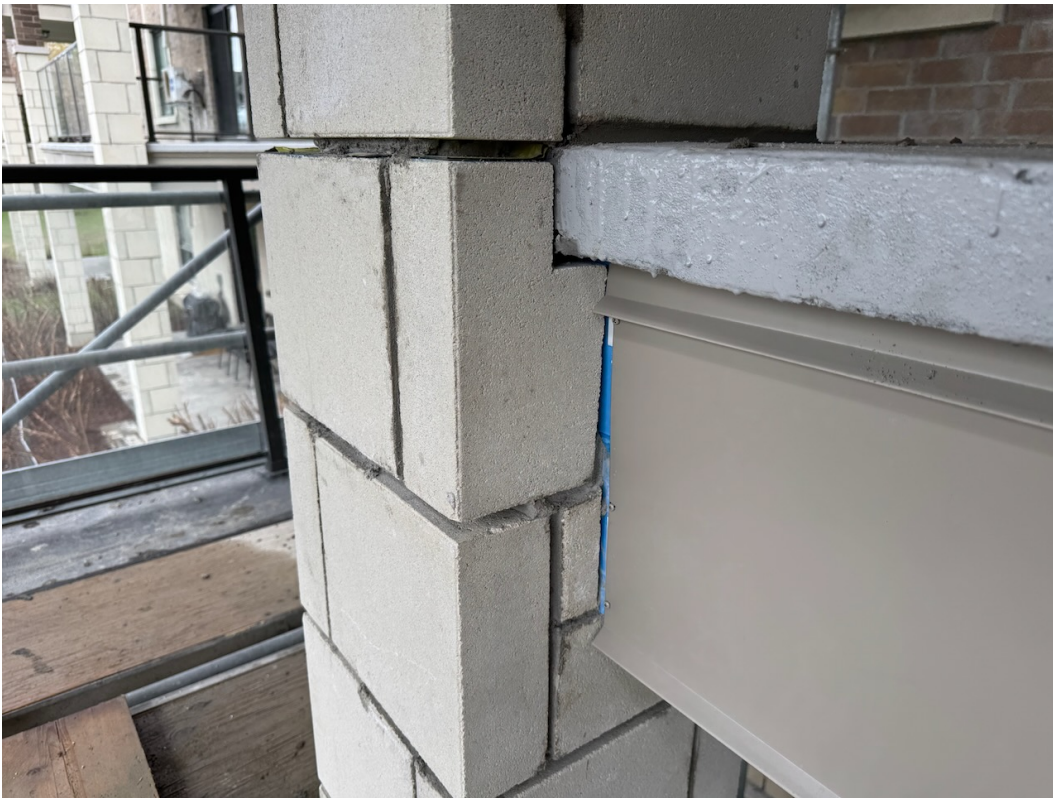
Photo 4: Balcony element installation ongoing.

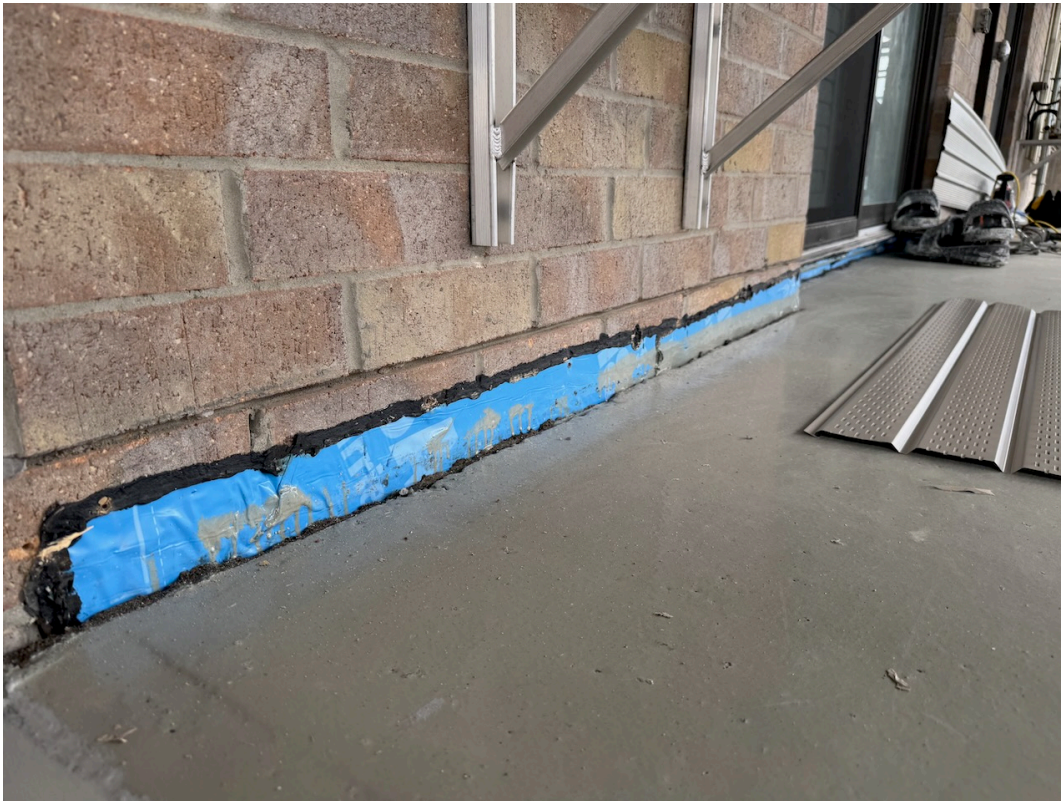
Photo 5: Blueskin membrane sealed the leading edge to the brick cladding.

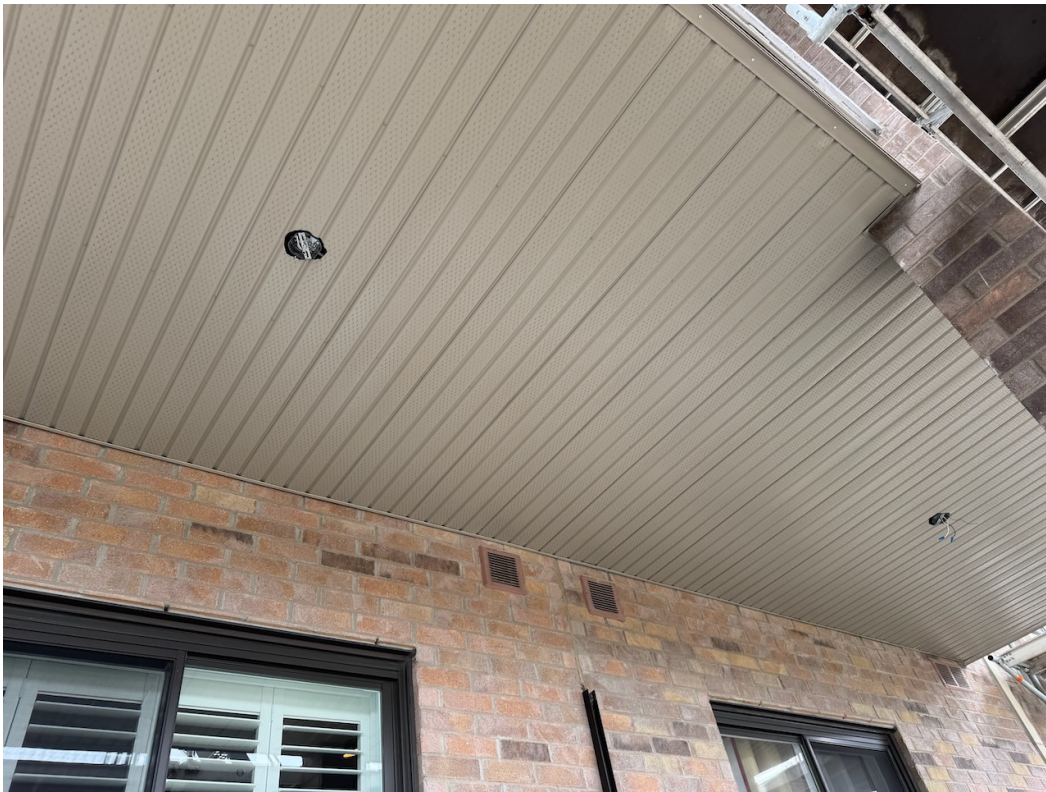
Photo 6: Soffit re-installation complete.

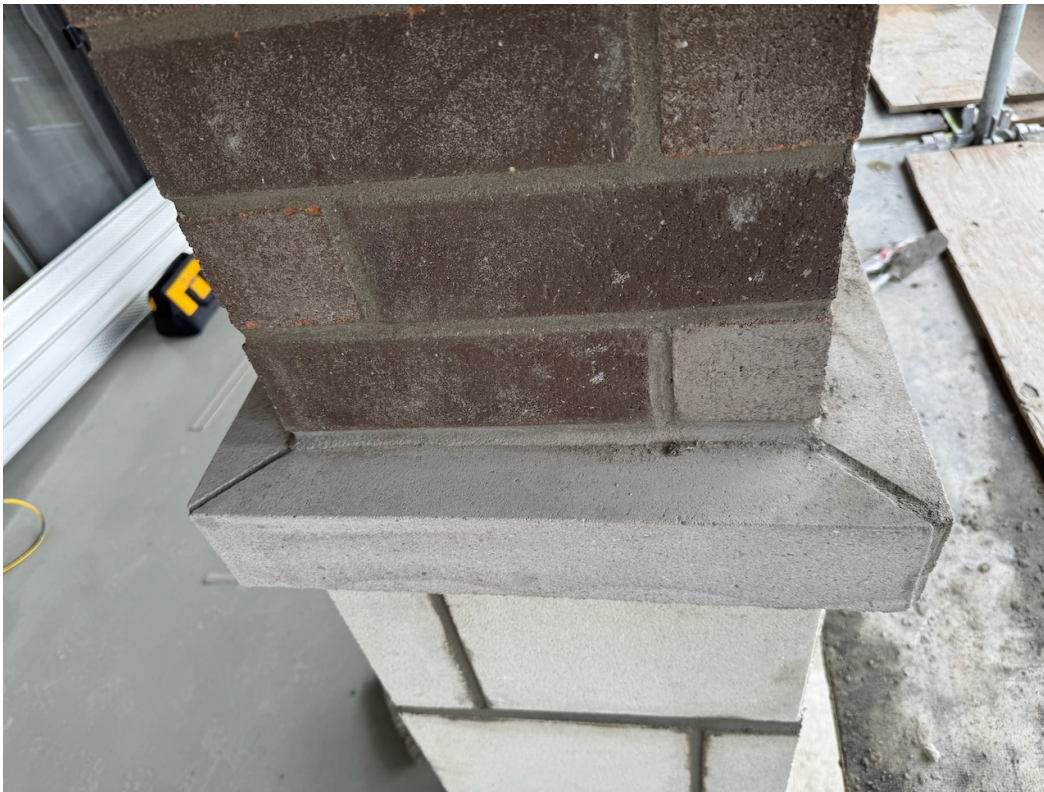
Photo 8: Masonry column cladding complete.

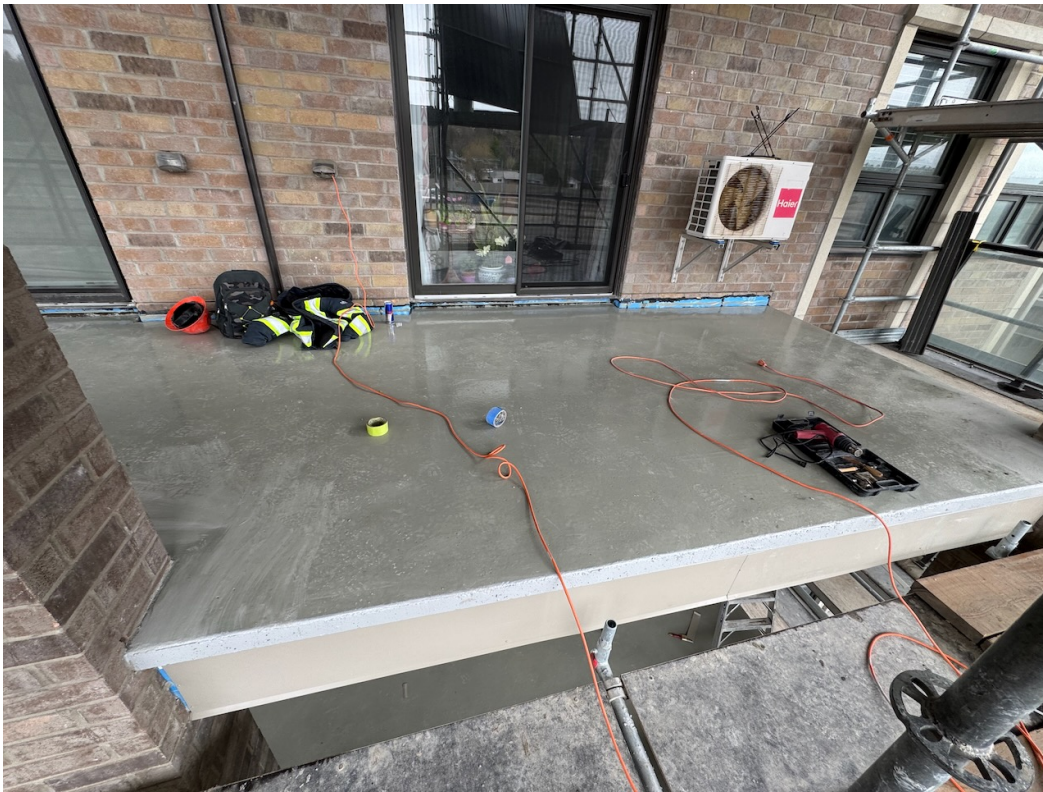
Photo 10: Base coat of the balcony traffic topping membrane.

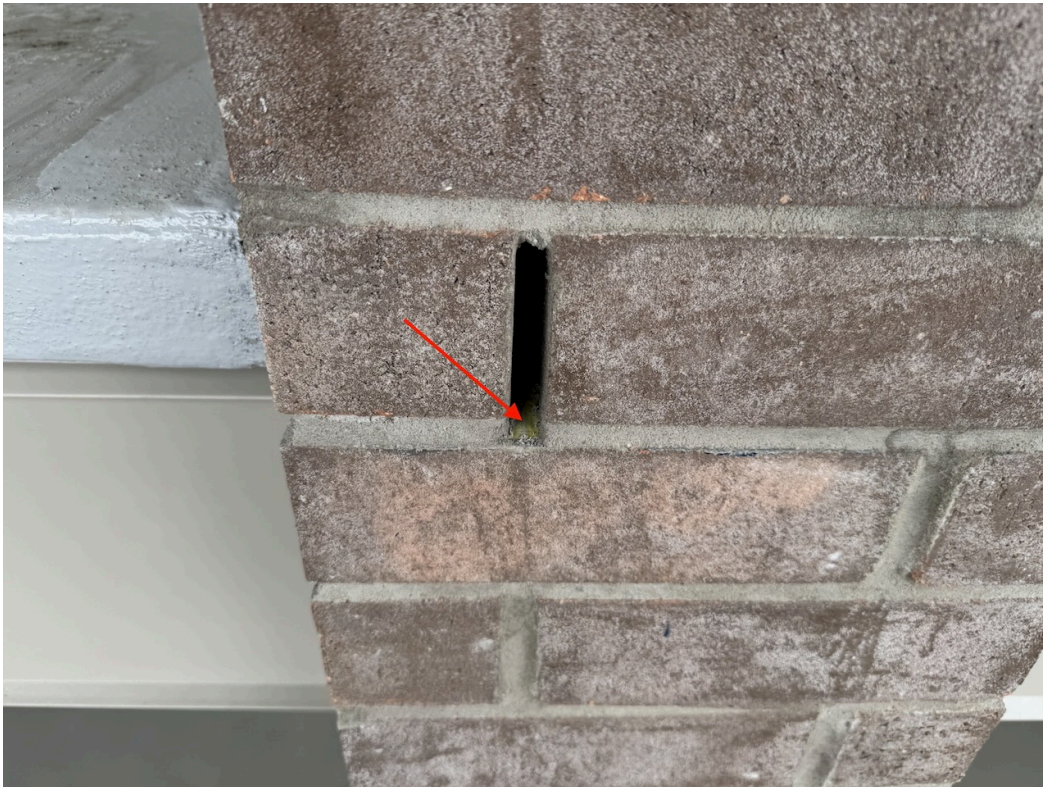
Photo 11: Blueskin TWF membrane installed at the balcony slab level through the masonry column cladding.

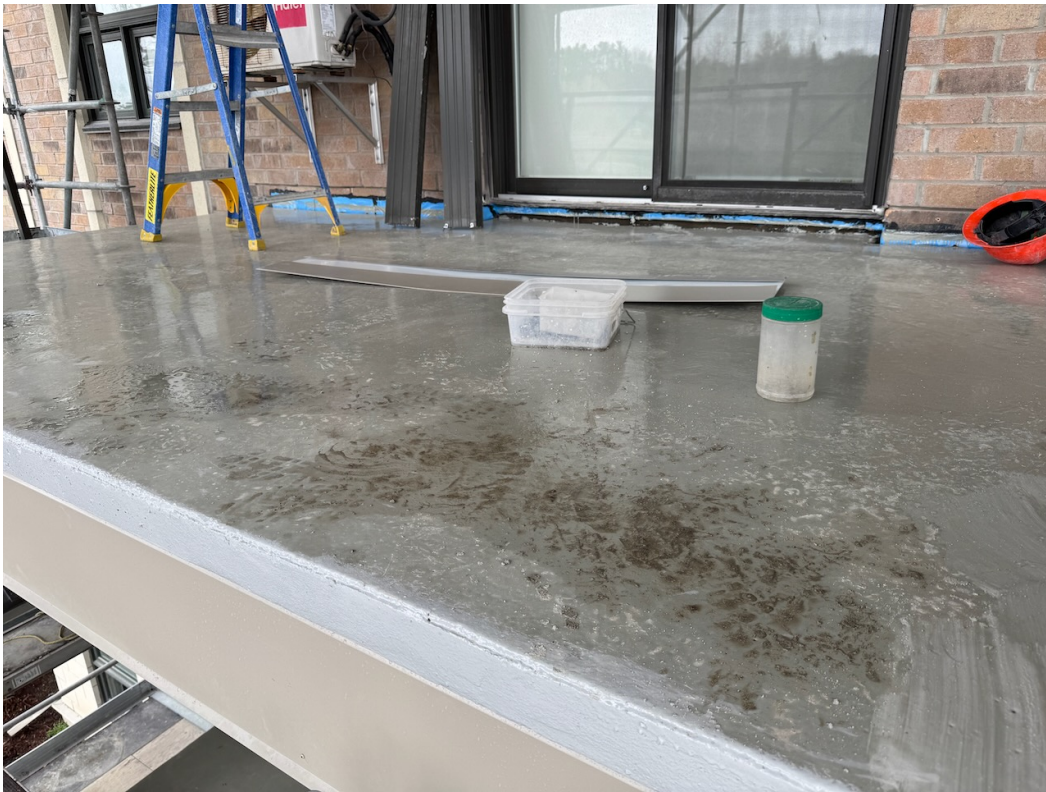
Photo 12: Base coat of the balcony traffic topping membrane.

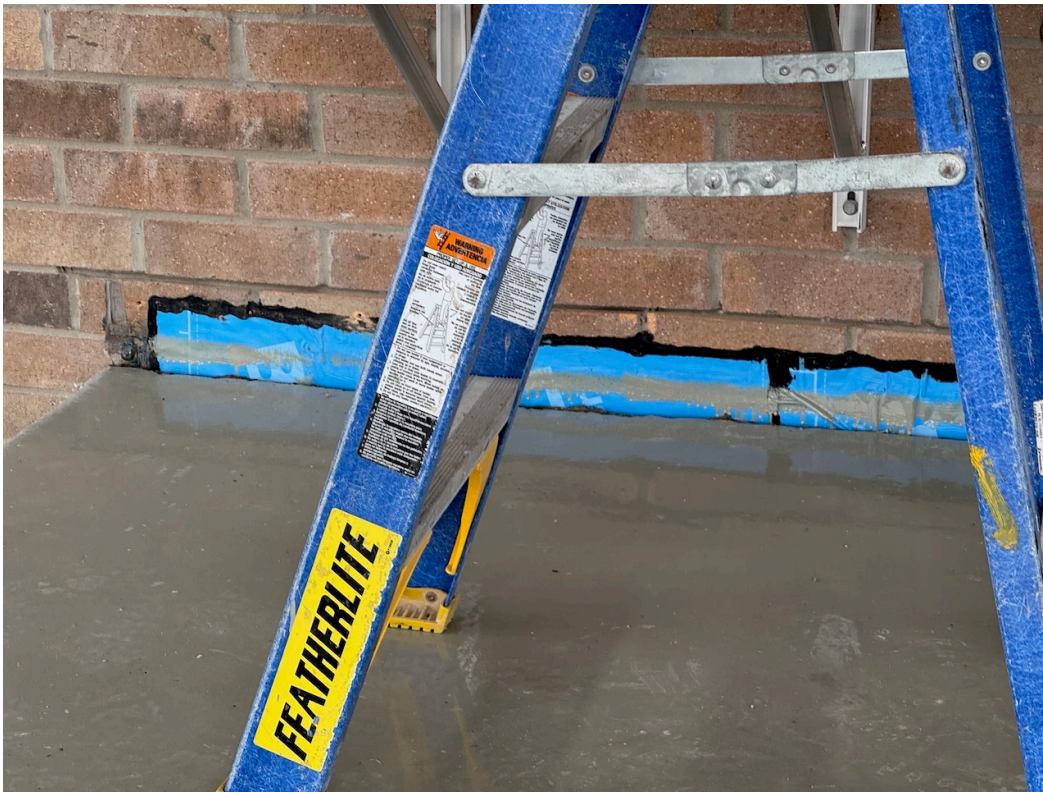
Photo 13: Blueskin membrane sealed the leading edge to the brick cladding.

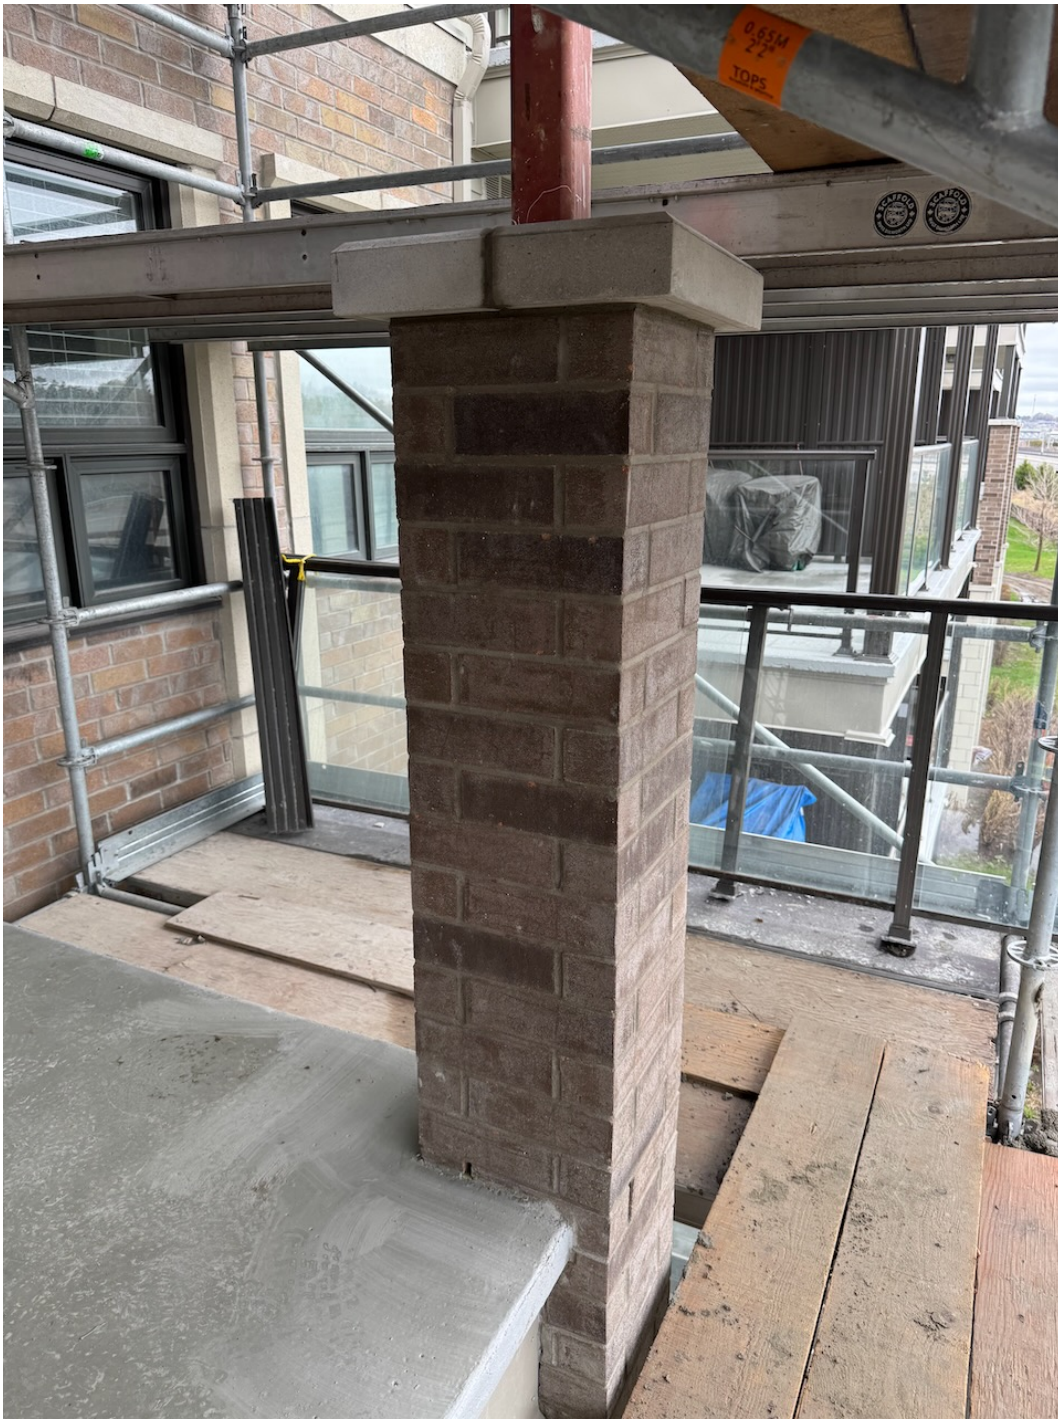
Photo 14: Balcony element installation ongoing.

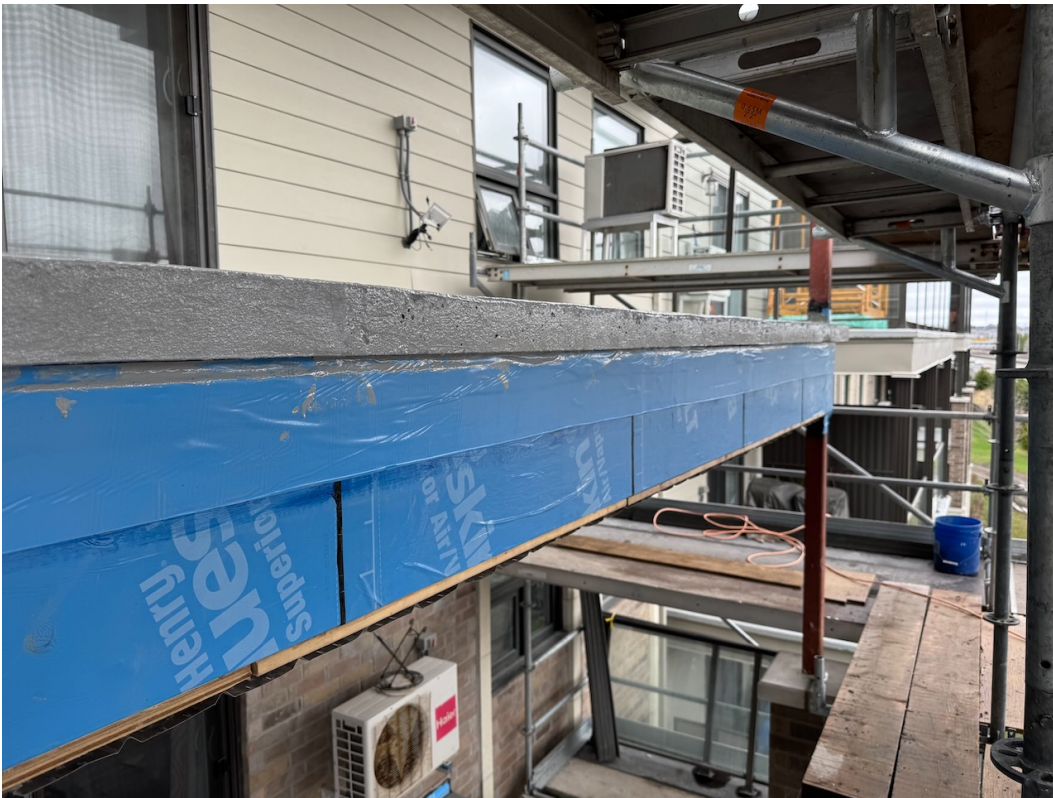
Photo 16: Blueskin membrane and traffic topping membrane complete.

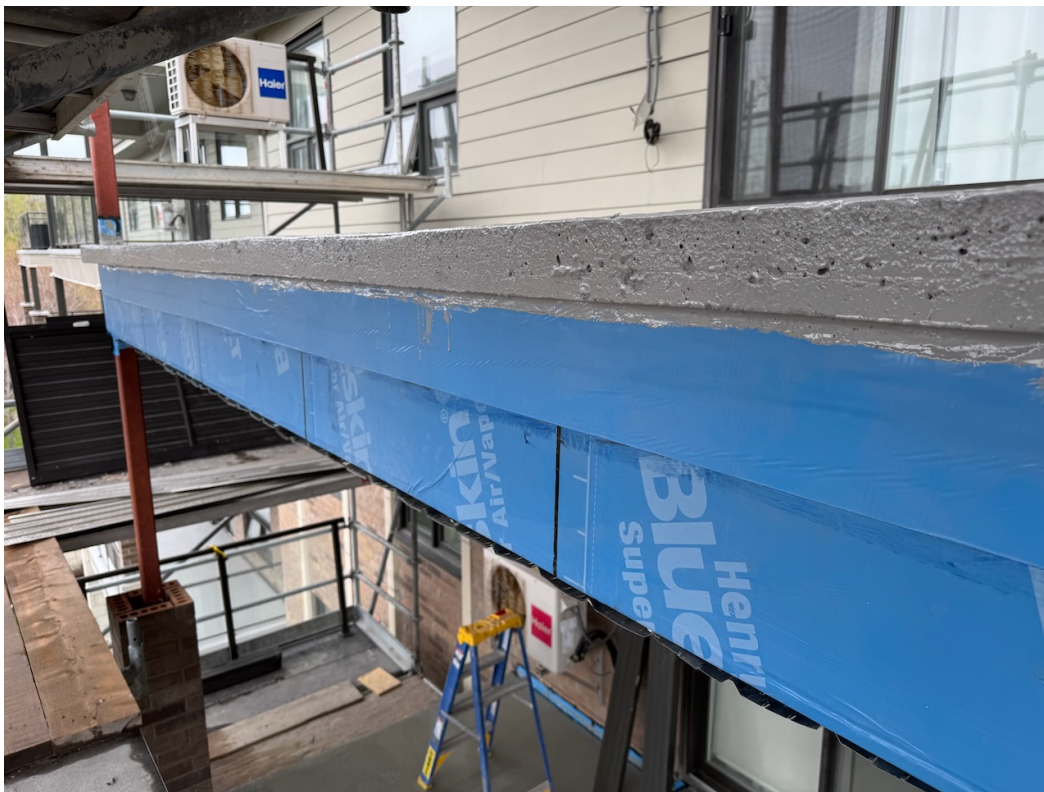
Photo 17: Blueskin membrane and traffic topping membrane complete.

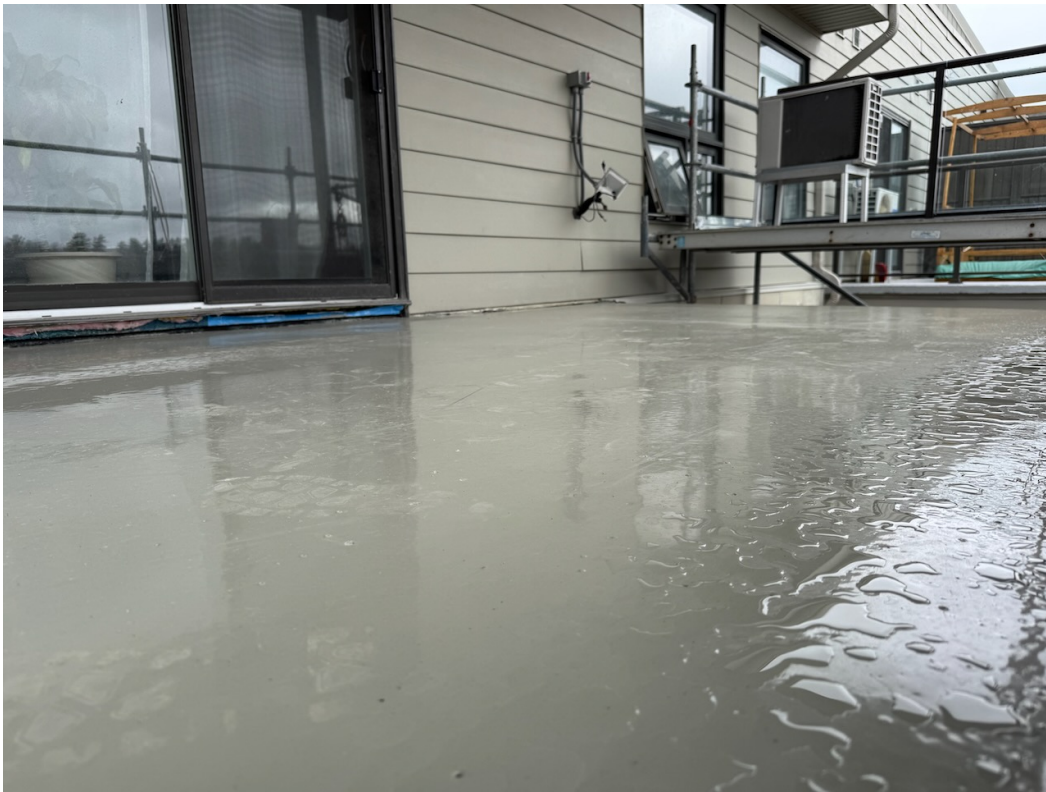
Photo 18: Traffic topping base coat complete.

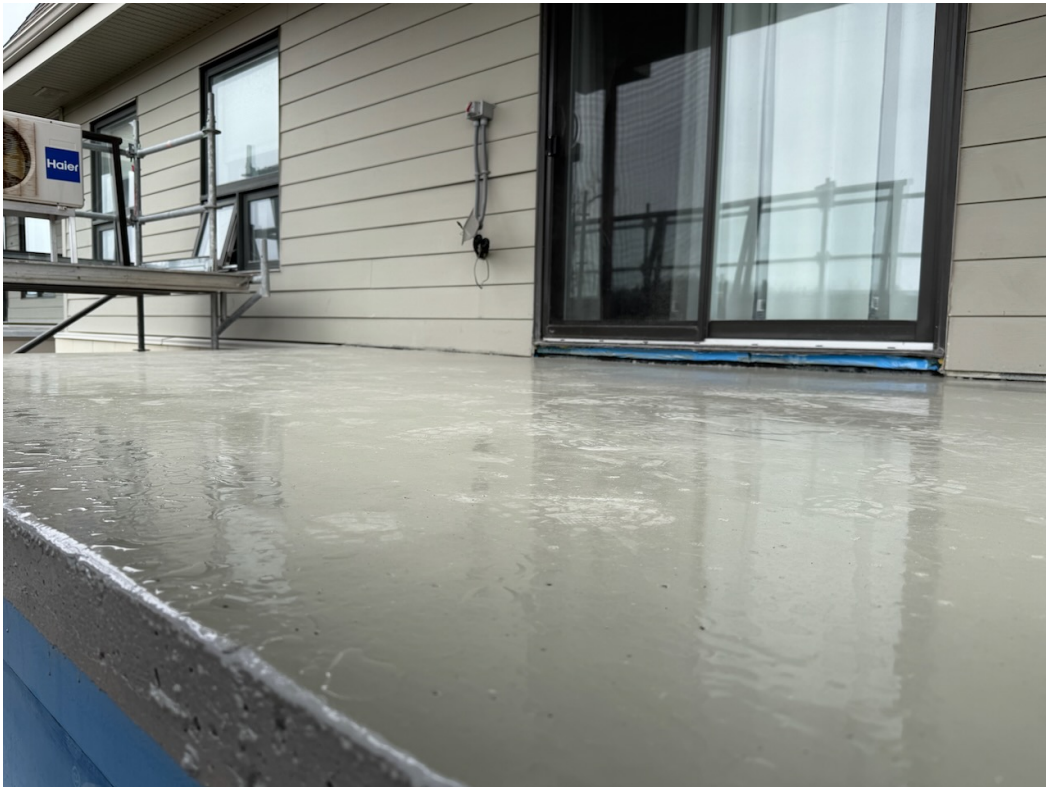
Photo 19: Traffic topping base coat complete.

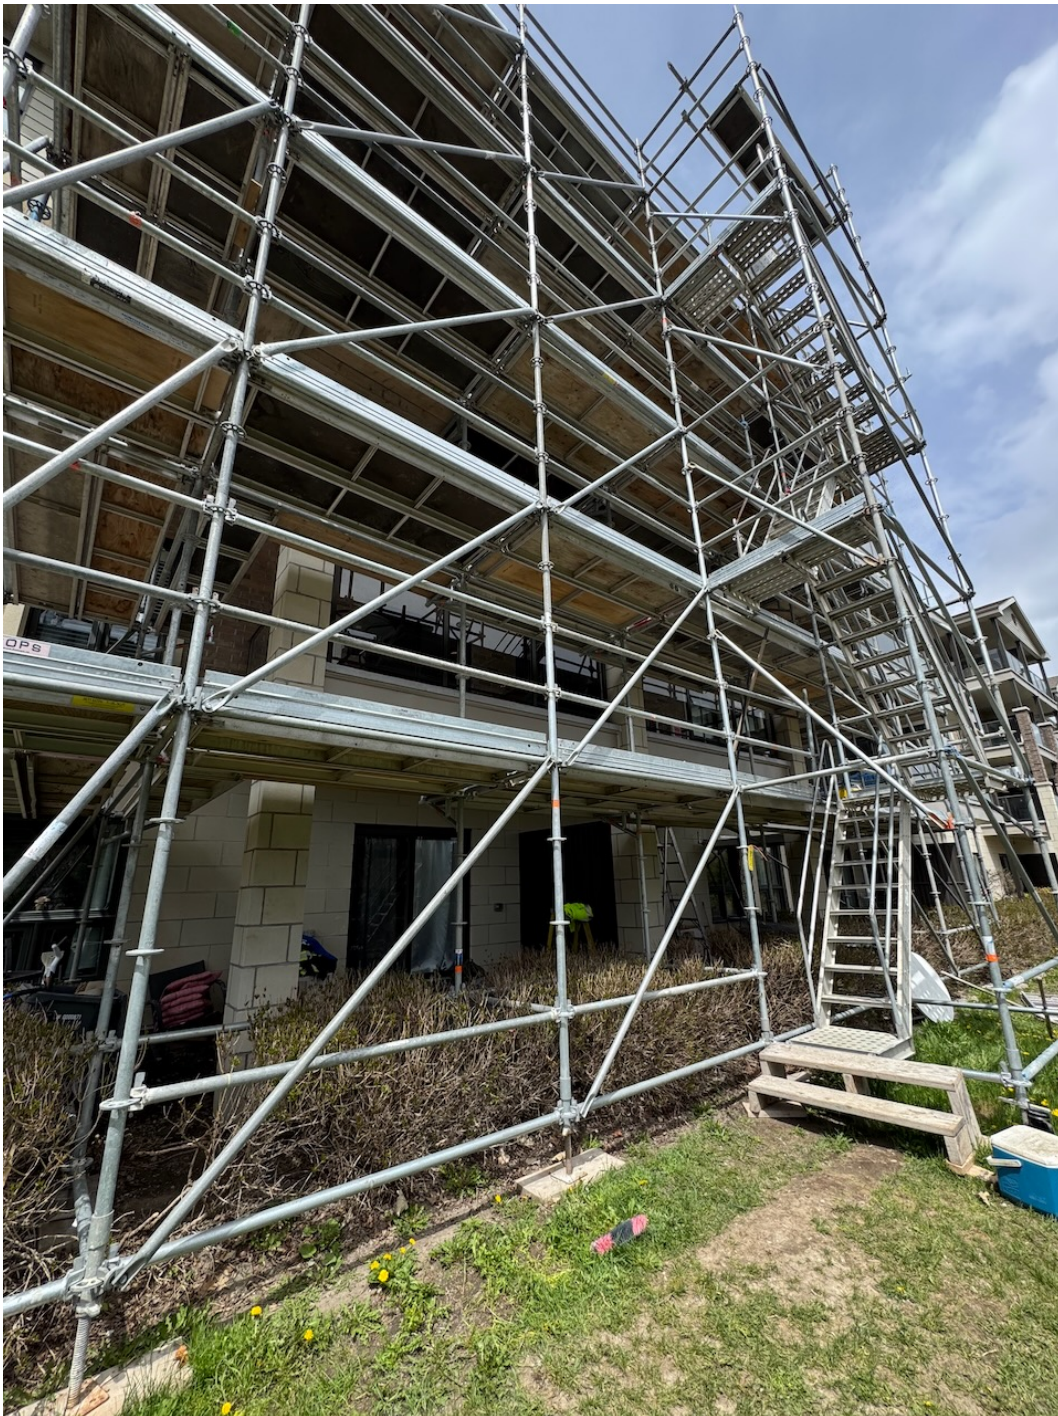
Photo 20: Drop 14 - May 11 - General view of the completed drop.

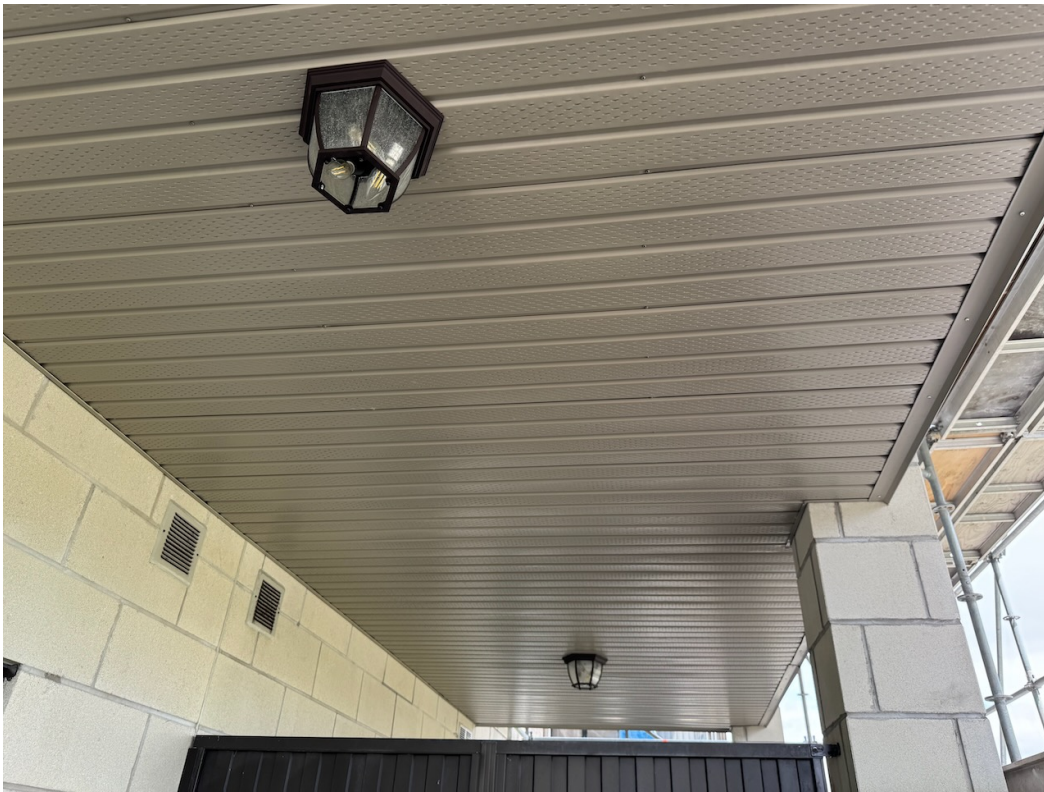
Photo 21: Soffits, flashing, and lights complete. These lights were replaced with new, as close as possible match to the original.

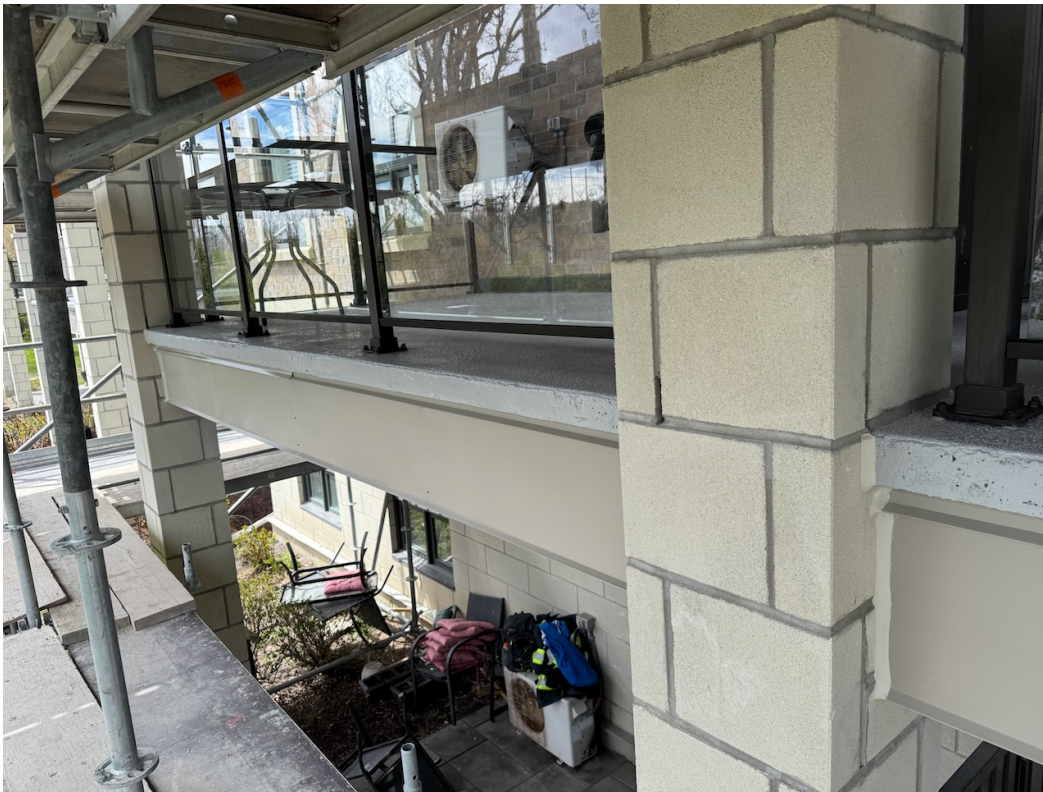
Photo 23: Masonry column cladding, flashing, caulking, and balcony traffic topping membrane complete. Guardrails re-installed.

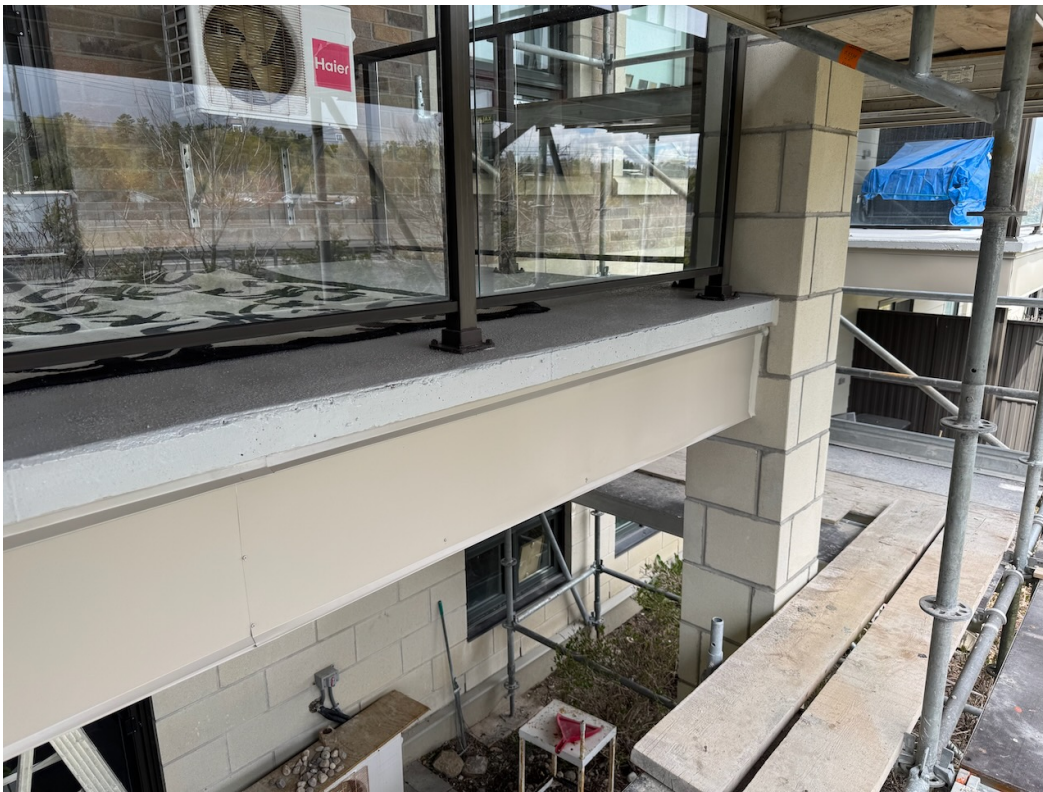
Photo 24: Masonry column cladding, flashing, caulking, and balcony traffic topping membrane complete. Guardrails re-installed.

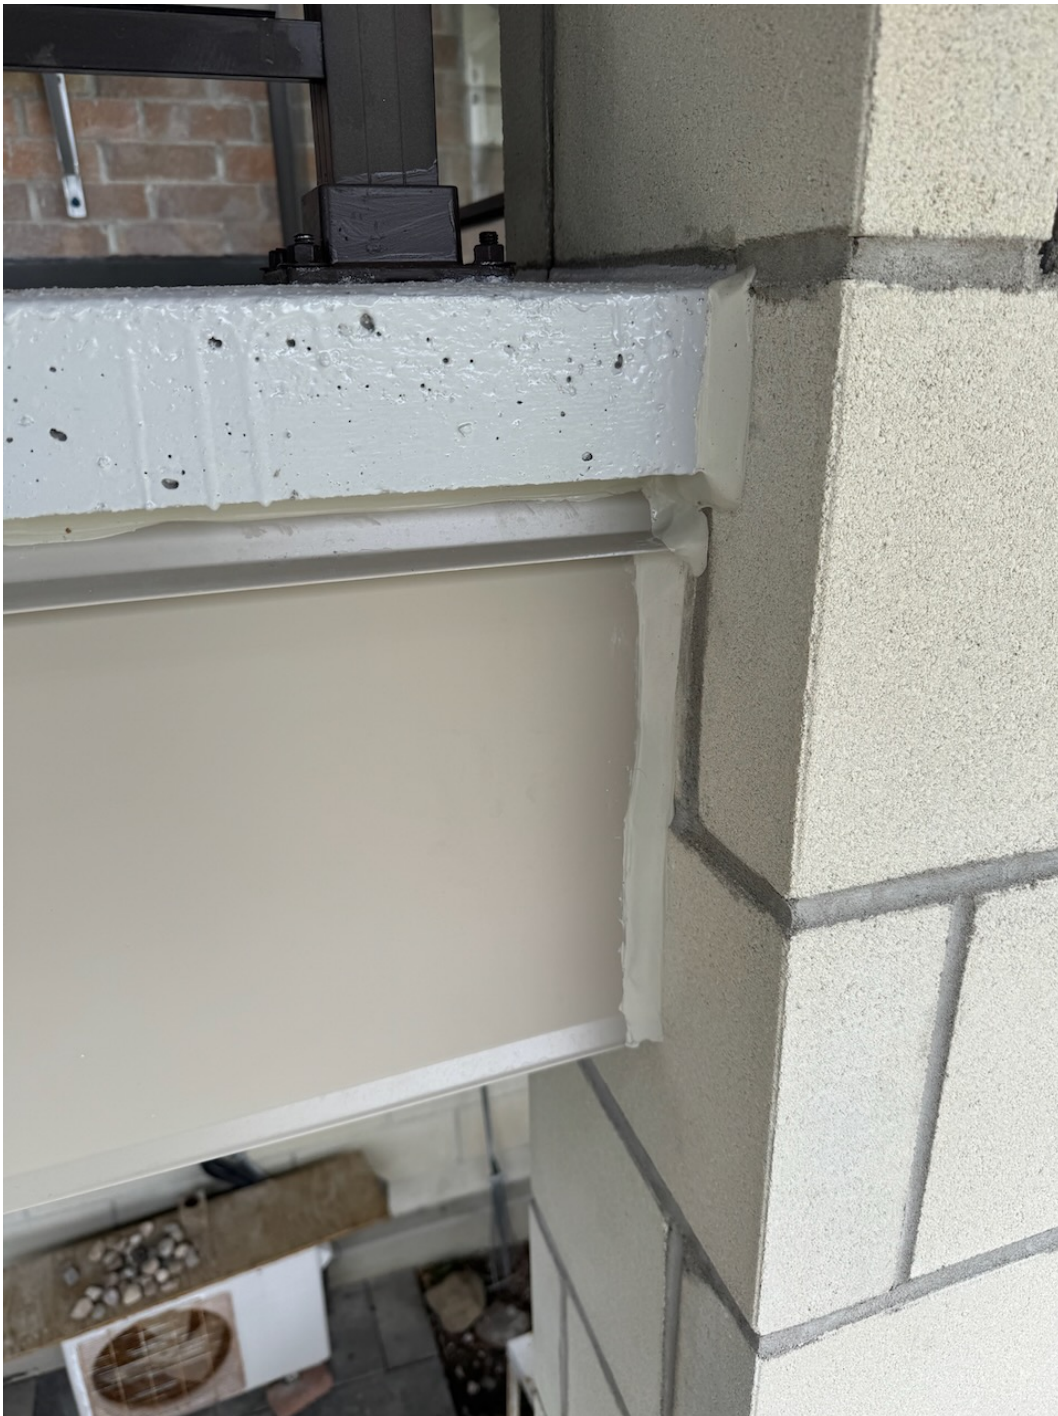
Photo 25: Close-up of the completed caulking.

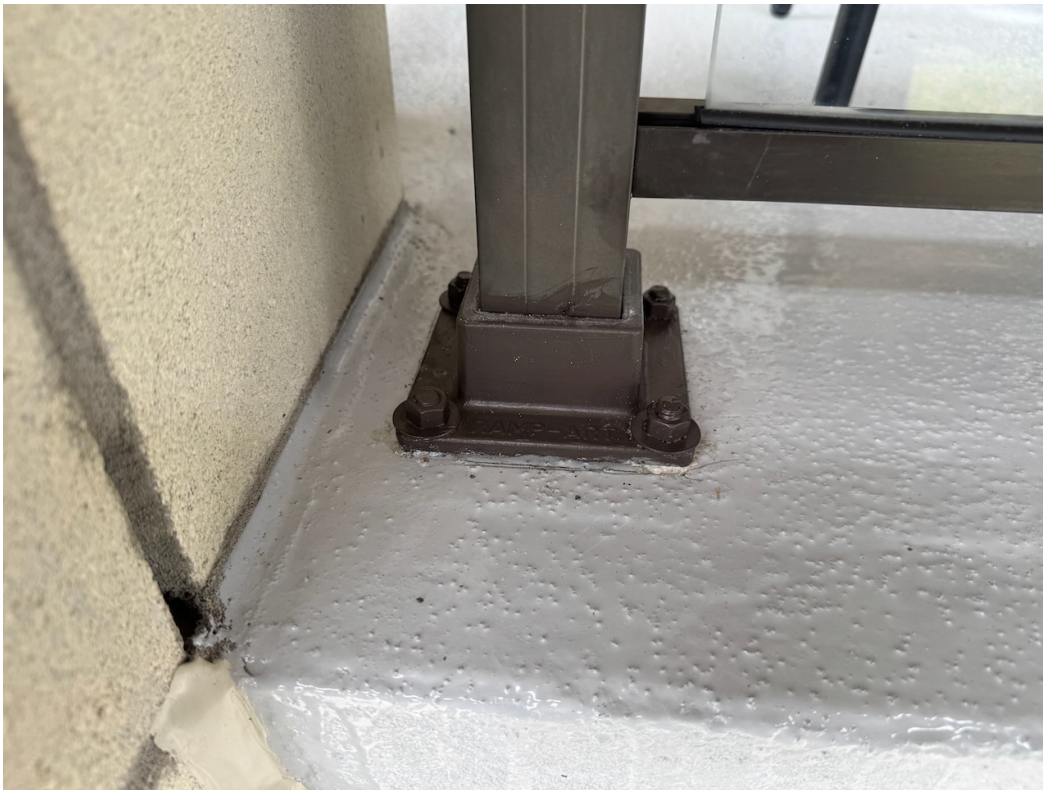
Photo 27: Guardrails re-installed.

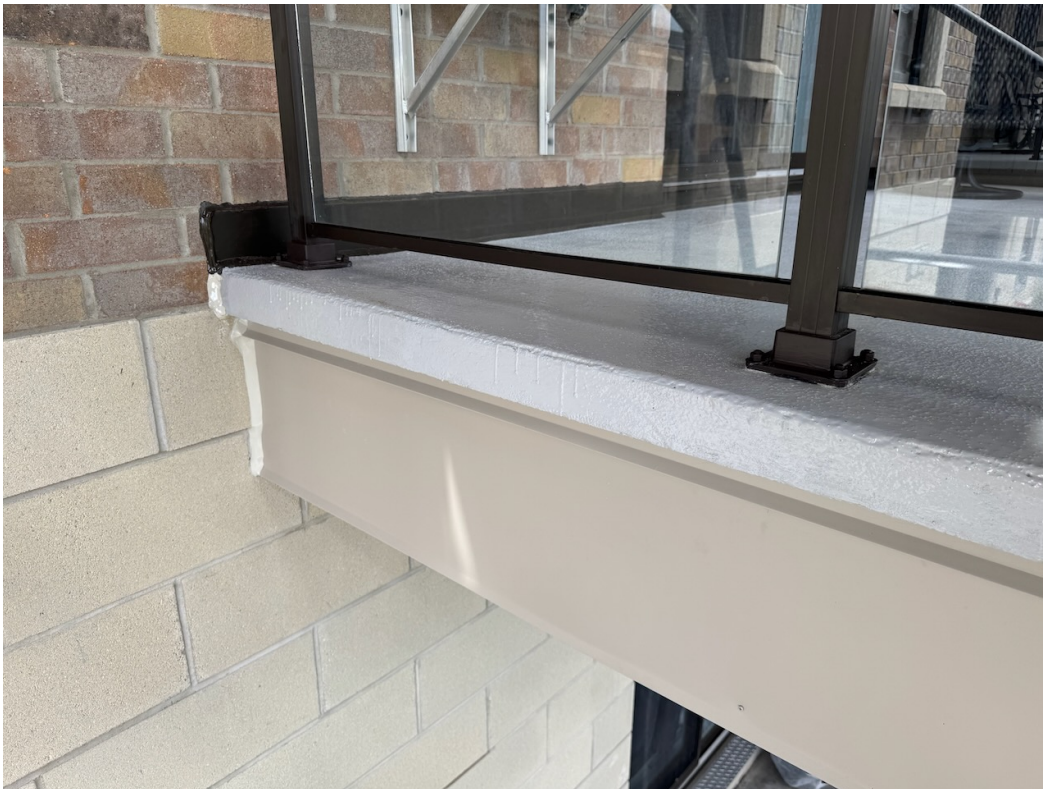
Photo 28: Flashing, caulking, and balcony traffic topping membrane complete. Guardrails re-installed.

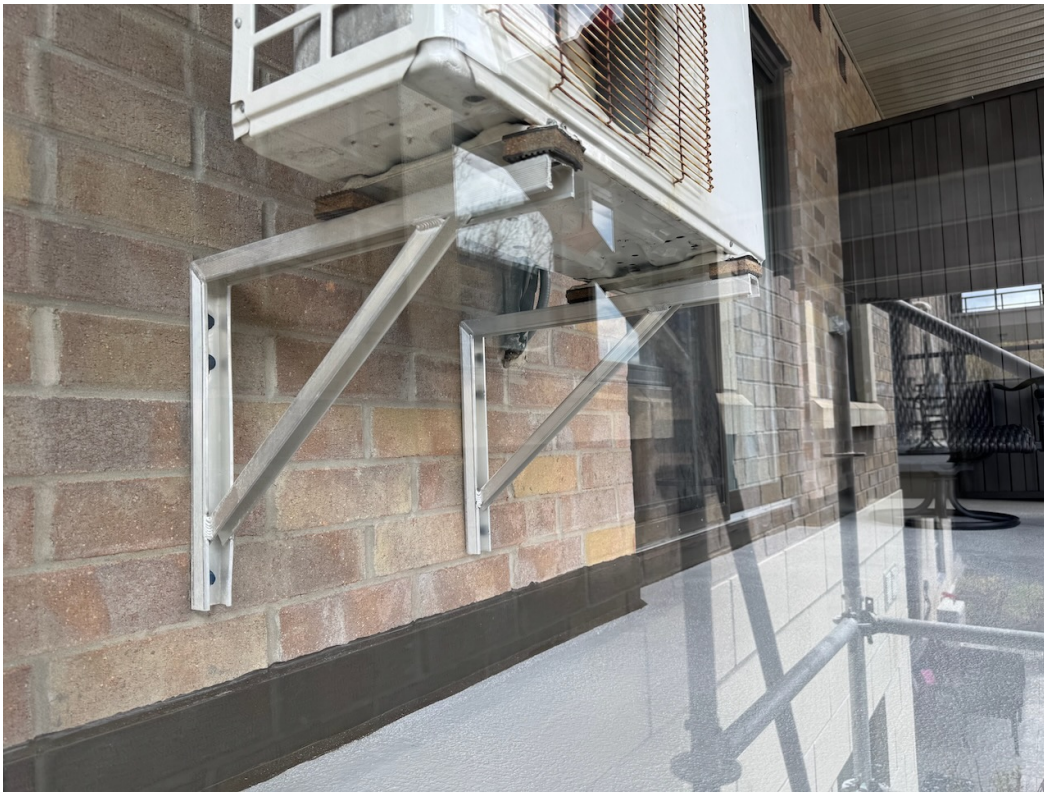
Photo 29: Base wall flashing and caulking complete. A/C unit re-installed.

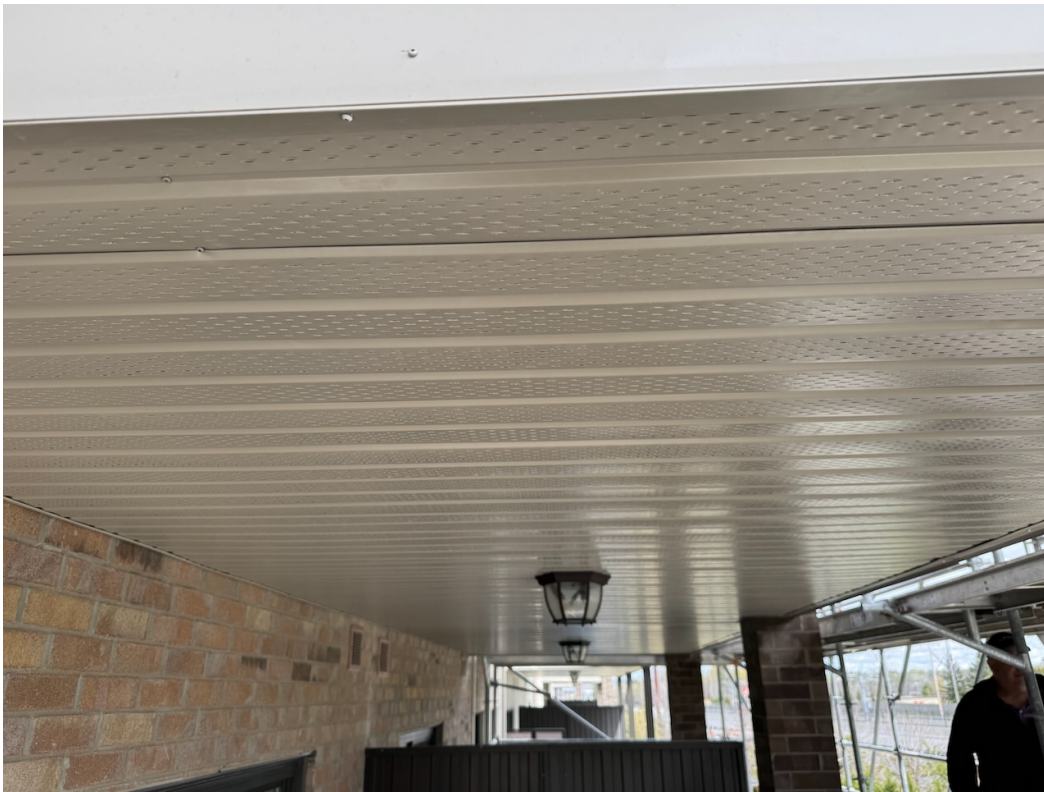
Photo 31: Soffit and light fixtures re-installed.
