Site Visit Report

Project:	Project No.:	Date:	Reviewed by:	Weather:	Report No.:
OCSCC 982 - Balcony Rehabilitation	7597.06	May 14, 2026	M.Cogliati	--	39
Total Site Visits to Date:					67

Area of Review: Drop 13 ('17)

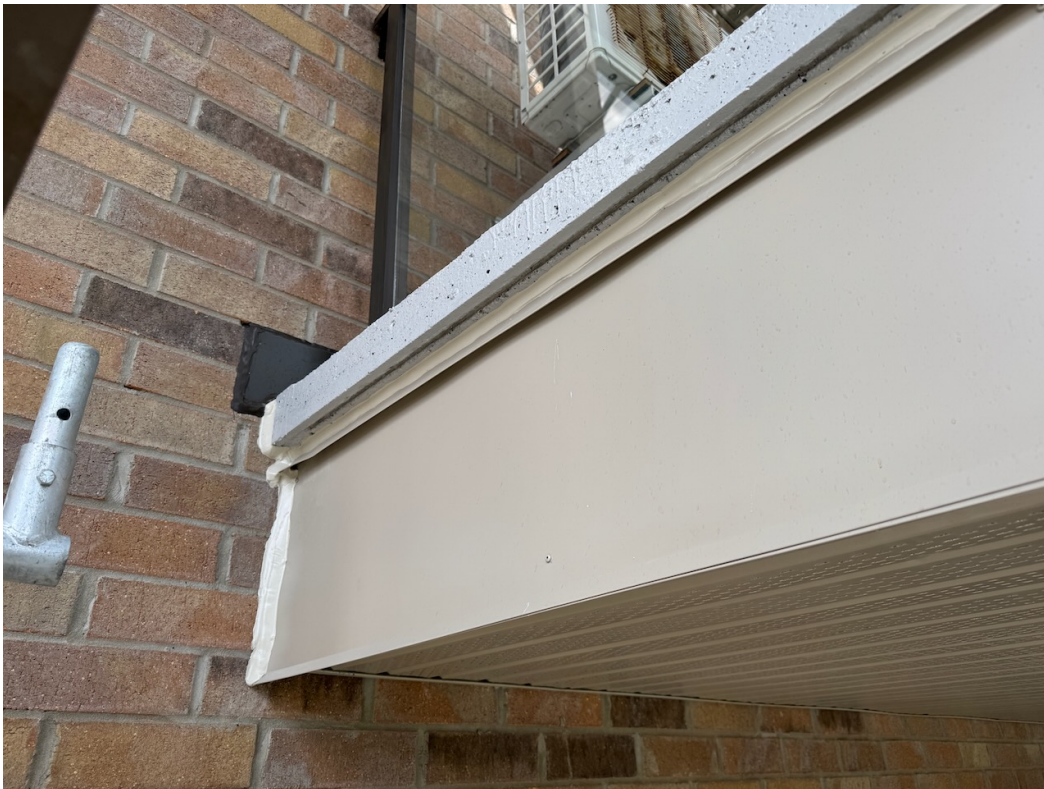
Photo 32: Flashing, caulking, and balcony traffic topping membrane complete. Guardrails re-installed.

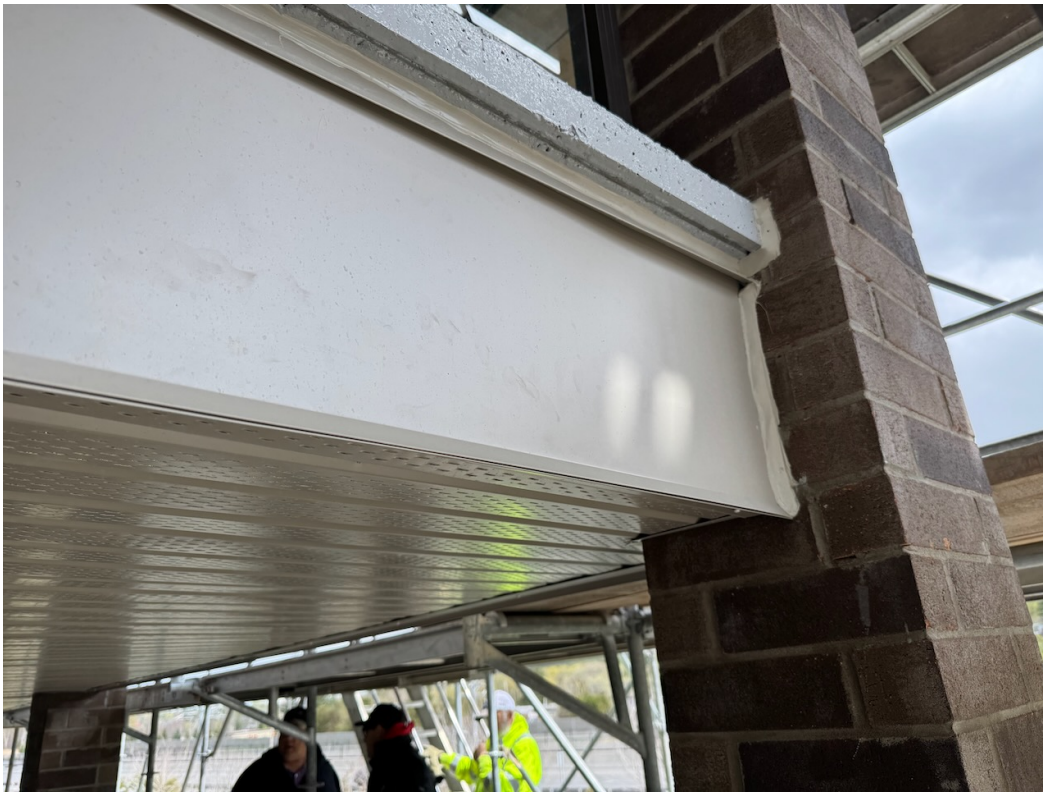
Photo 33: Masonry column cladding, flashing, caulking, and balcony traffic topping membrane complete. Guardrails re-installed.

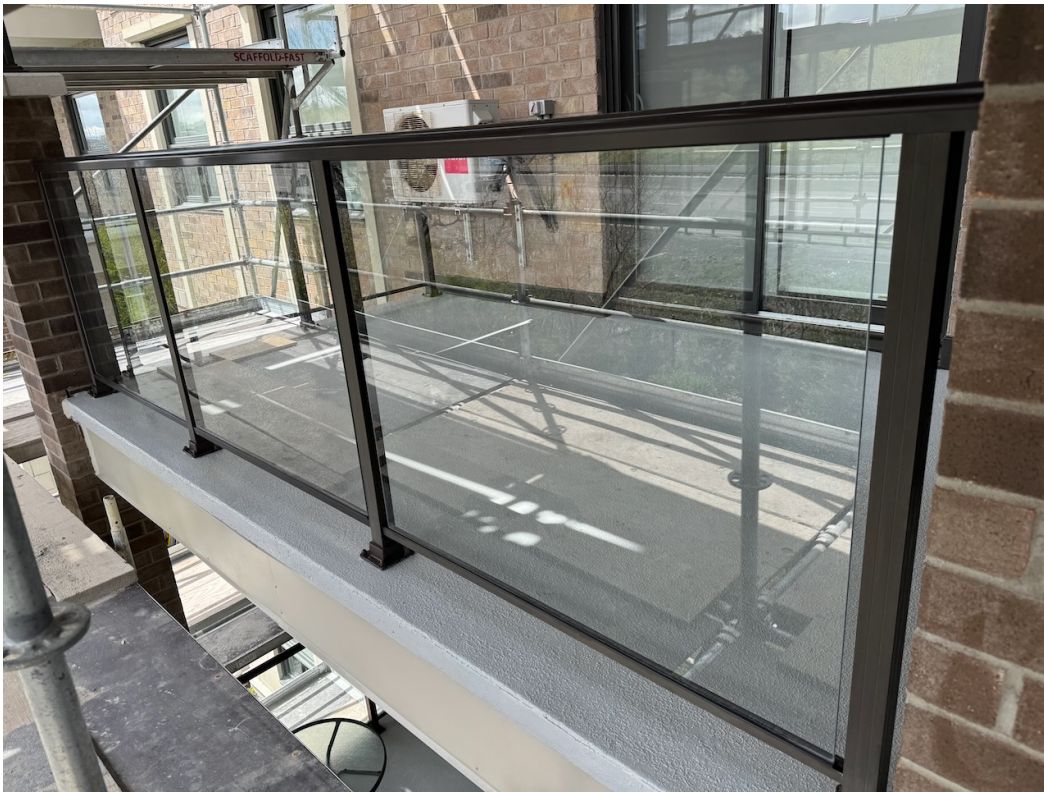
Photo 34: Masonry column cladding, flashing, caulking, and balcony traffic topping membrane complete. Guardrails re-installed.

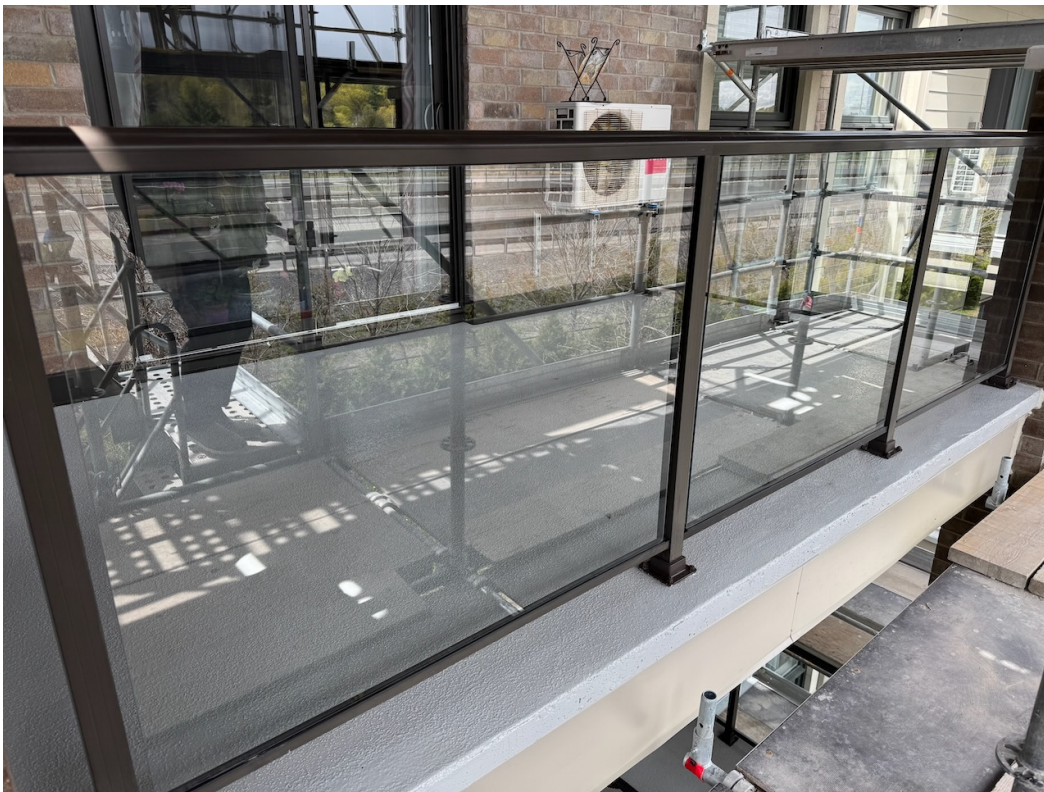
Photo 35: Masonry column cladding, flashing, caulking, and balcony traffic topping membrane complete. Guardrails re-installed.

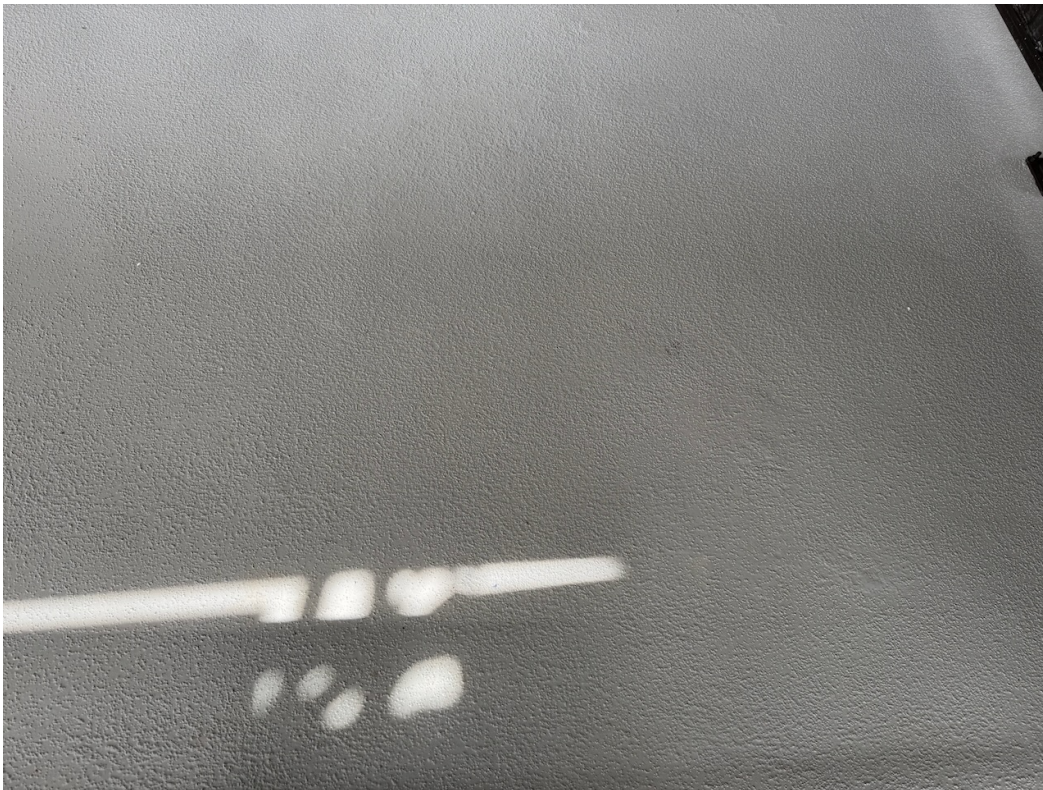
Photo 36: Complete traffic topping membrane.

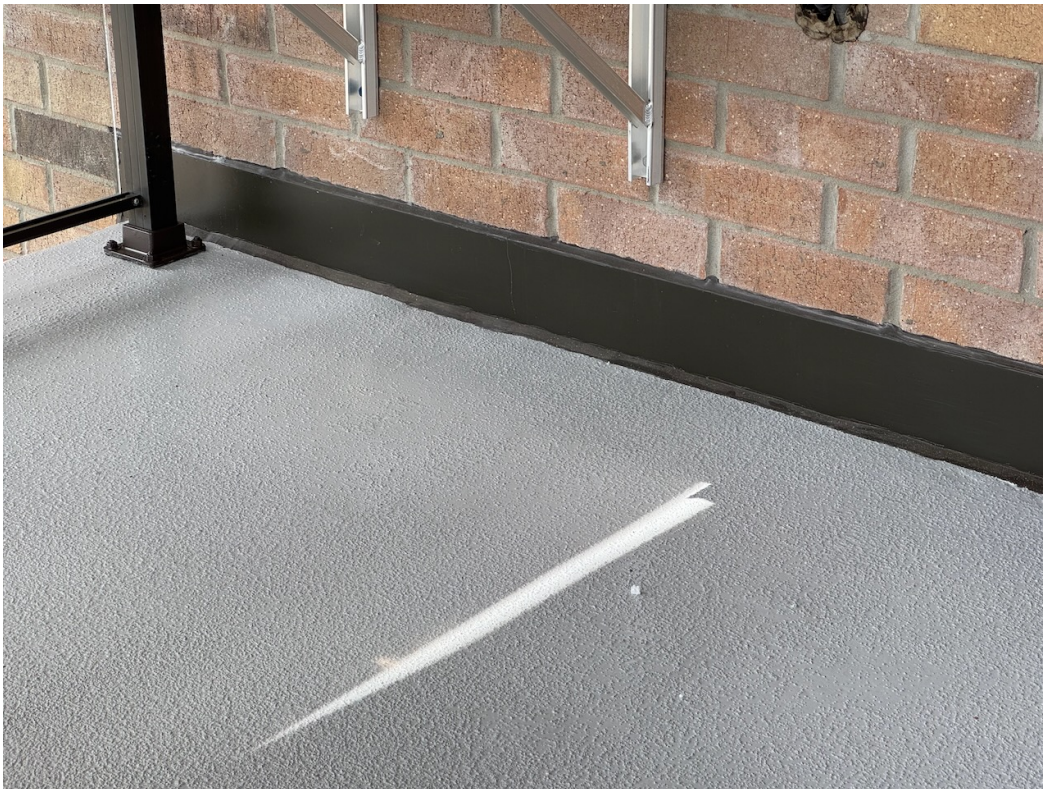
Photo 37: Complete base wall flashing and caulking complete.

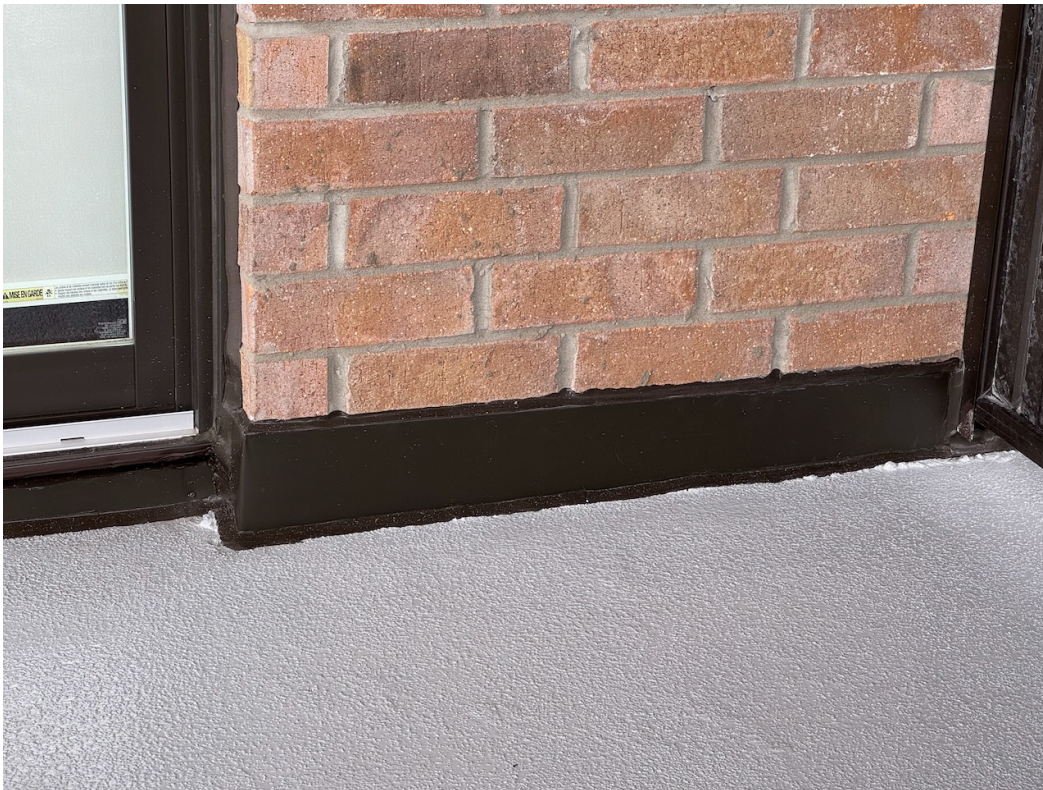
Photo 38: Complete base wall flashing and caulking complete.

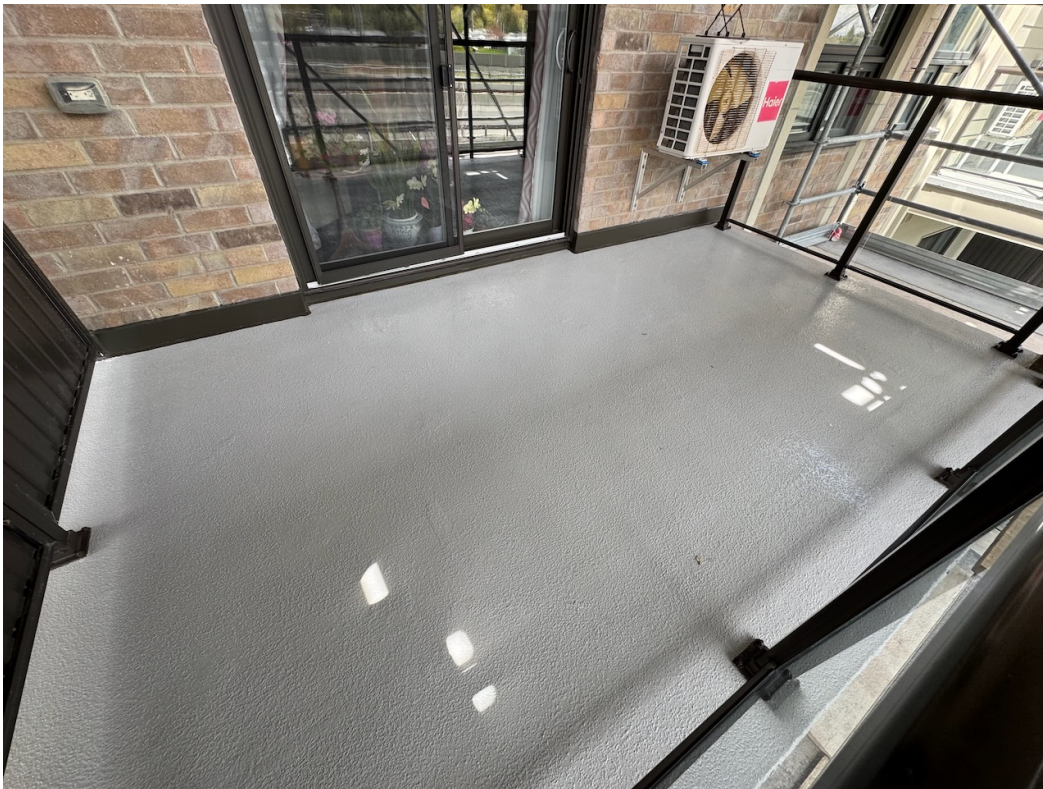
Photo 39: Traffic topping membrane complete.

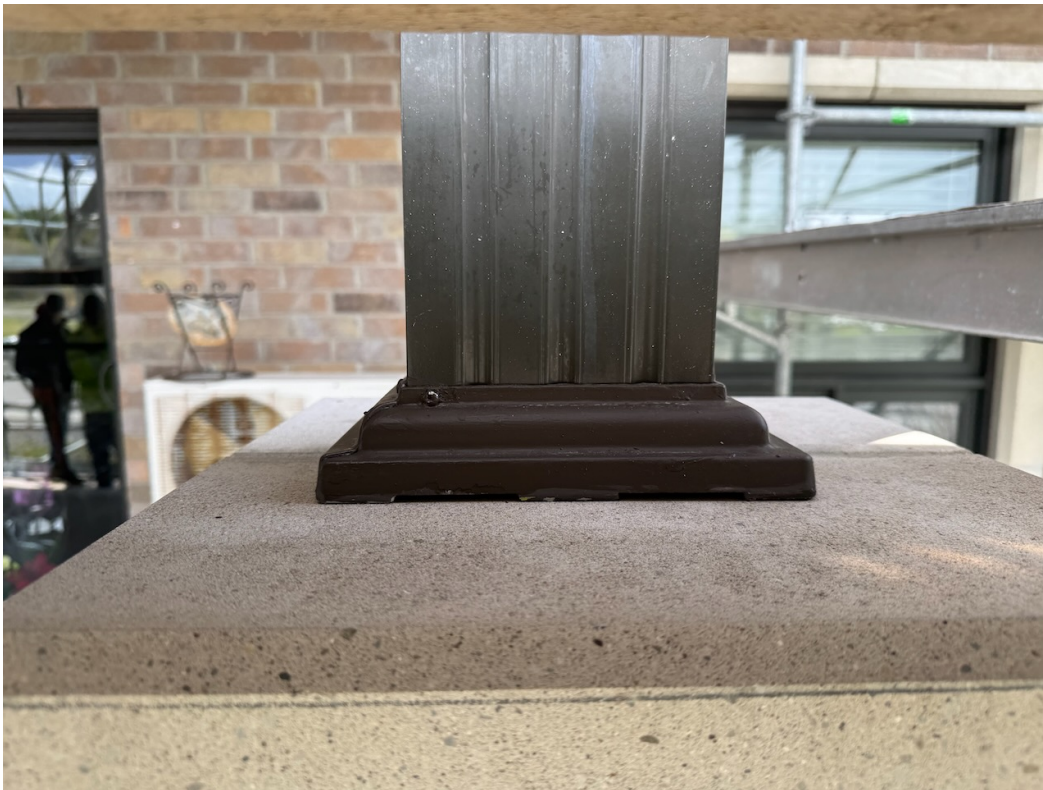
Photo 40: Aluminum columns cladding re-installed.

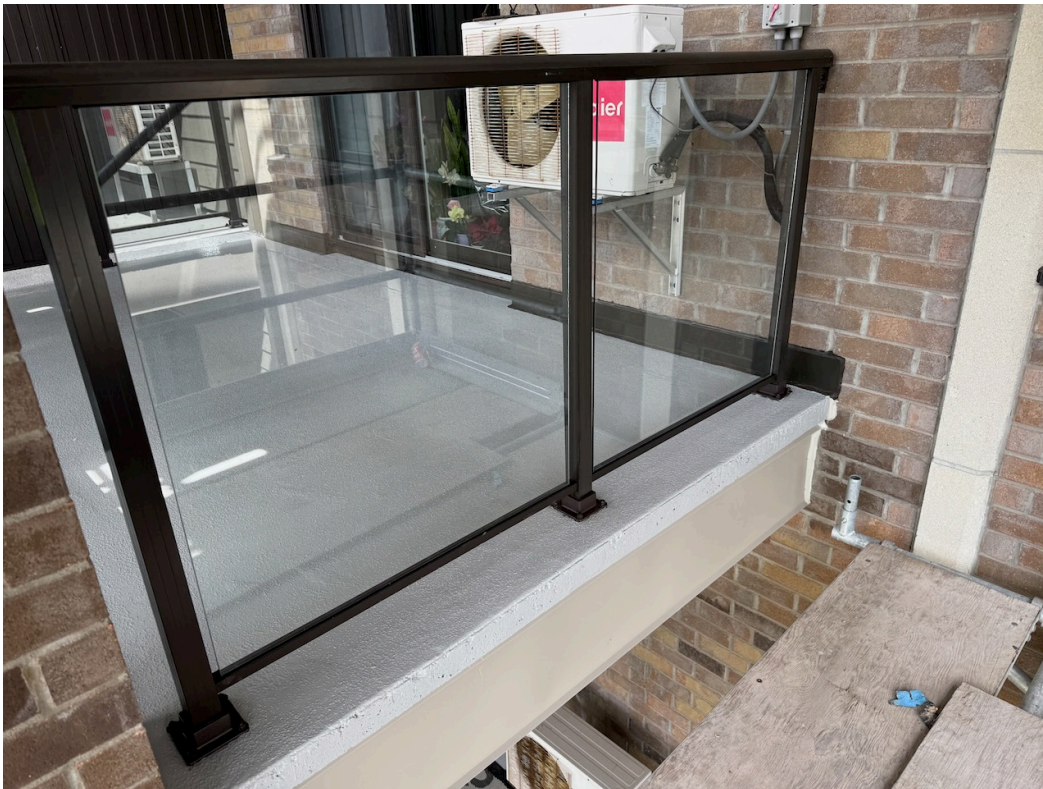
Photo 41: Masonry column cladding, flashing, caulking, and balcony traffic topping membrane complete. Guardrails re-installed.

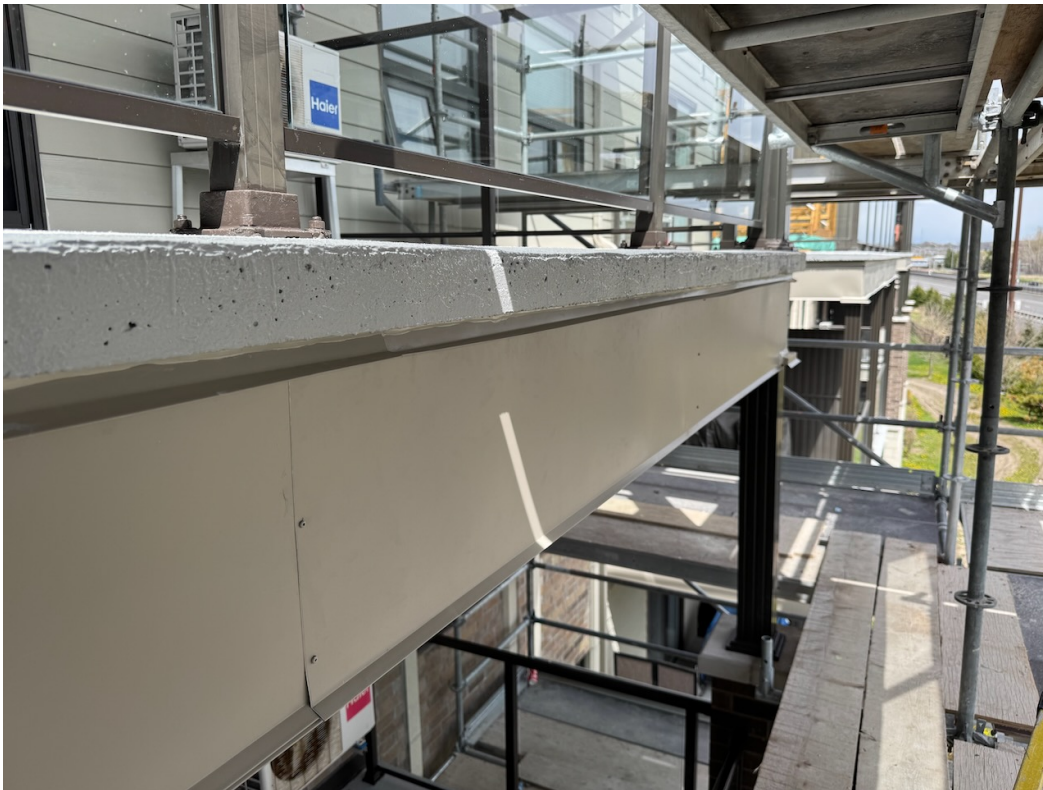
Photo 42: Aluminum column cladding, flashing, caulking, and balcony traffic topping membrane complete. Guardrails re-installed.

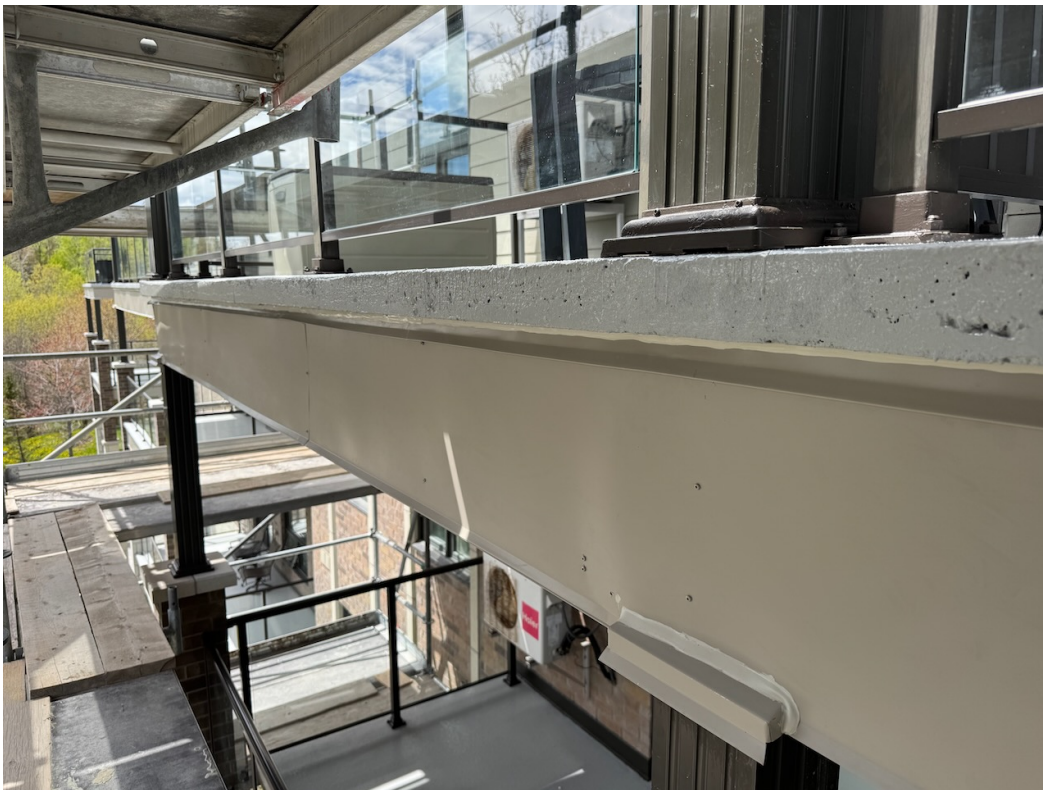
Photo 43: Aluminum column cladding, flashing, caulking, and balcony traffic topping membrane complete. Guardrails re-installed.

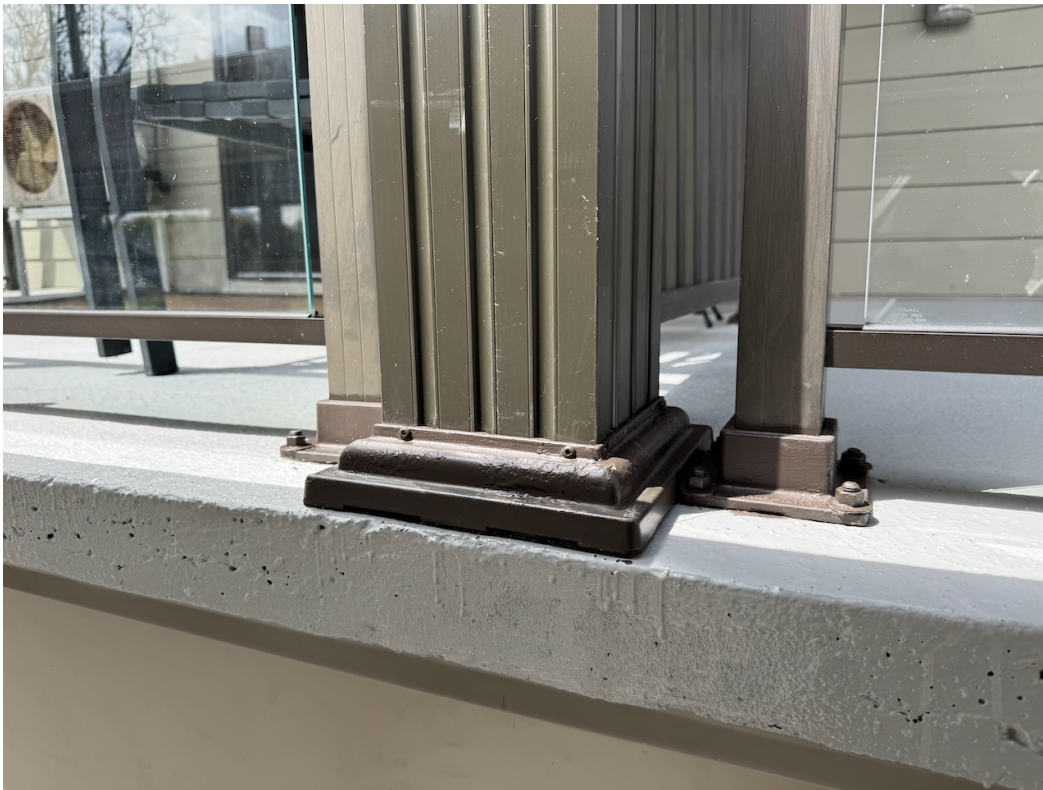
Photo 44: Aluminum column cladding, flashing, caulking, and balcony traffic topping membrane complete. Guardrails re-installed.

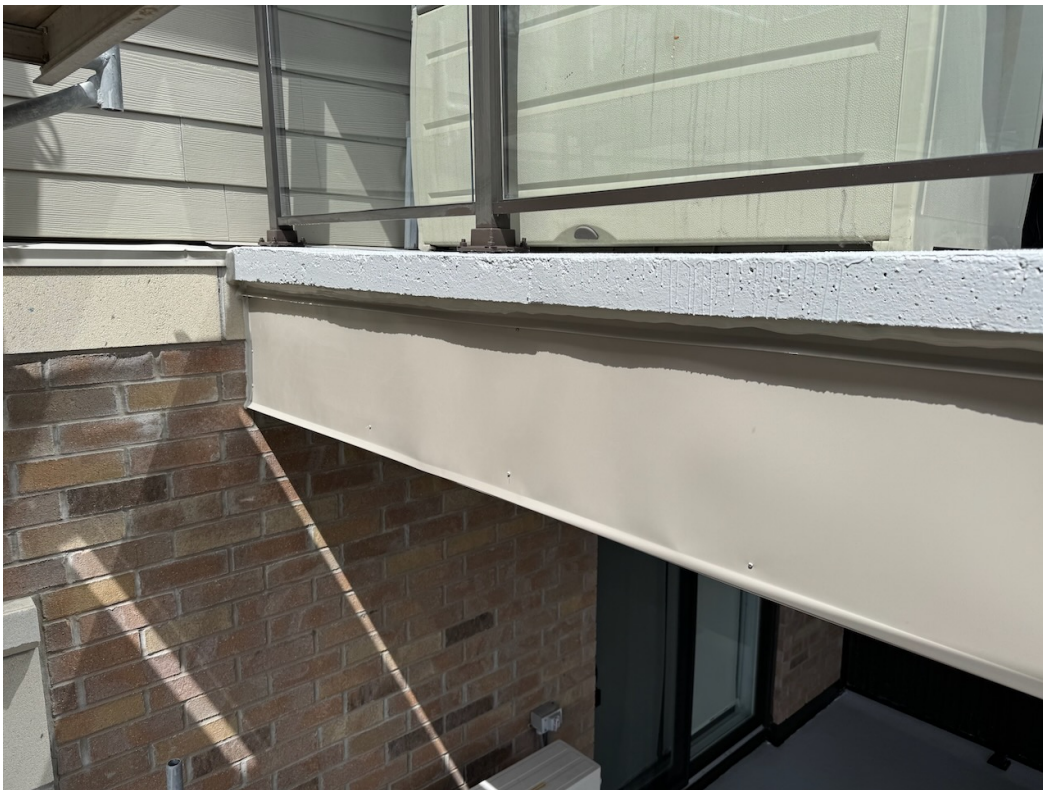
Photo 45: Aluminum column cladding, flashing, caulking, and balcony traffic topping membrane complete. Guardrails re-installed.

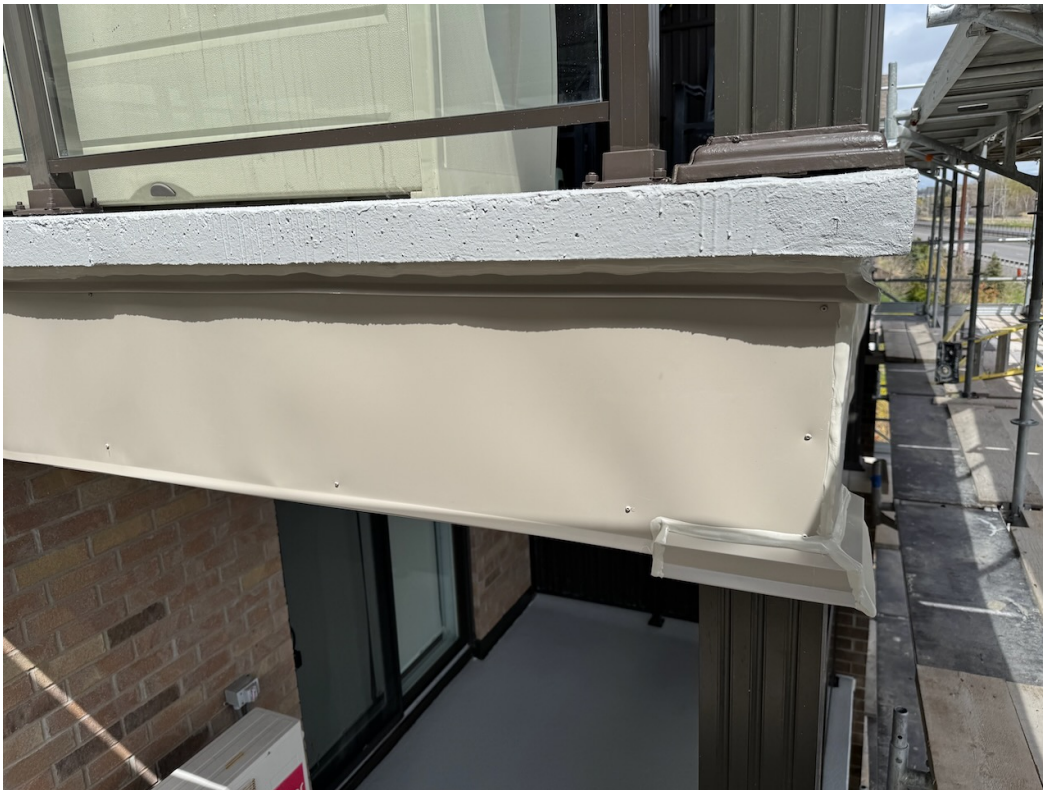
Photo 46: Aluminum column cladding, flashing, caulking, and balcony traffic topping membrane complete. Guardrails re-installed.

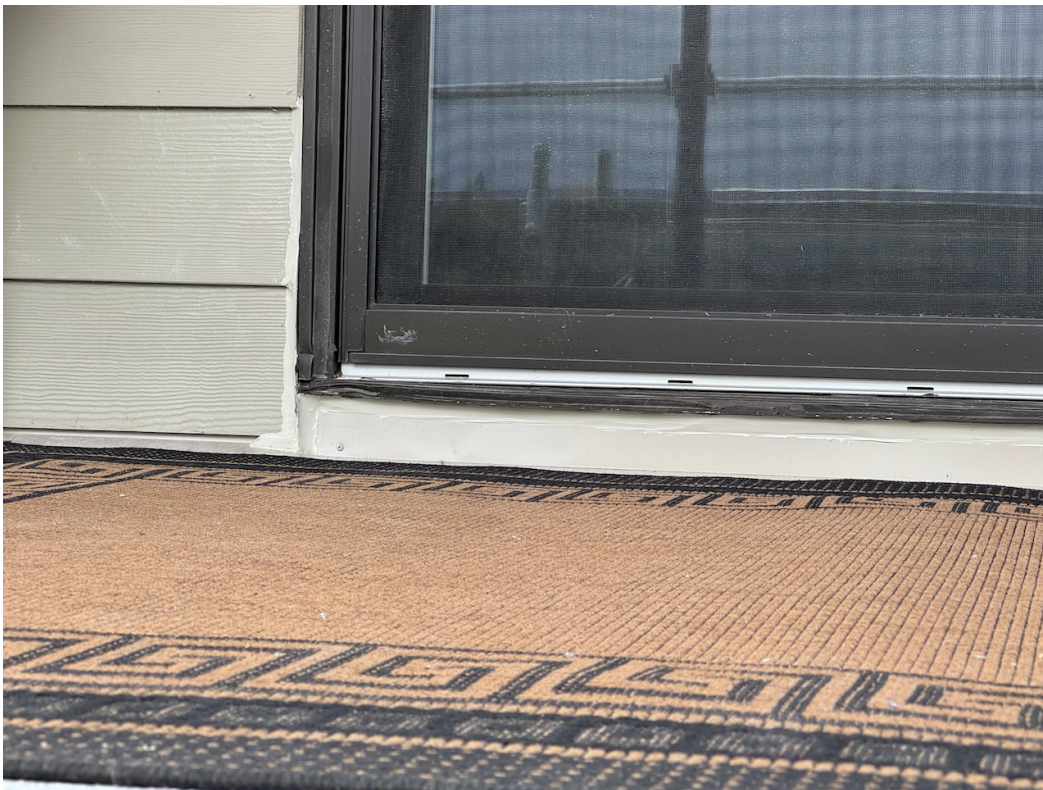
Photo 47: Caulking and flashing complete at the base wall around the patio door.

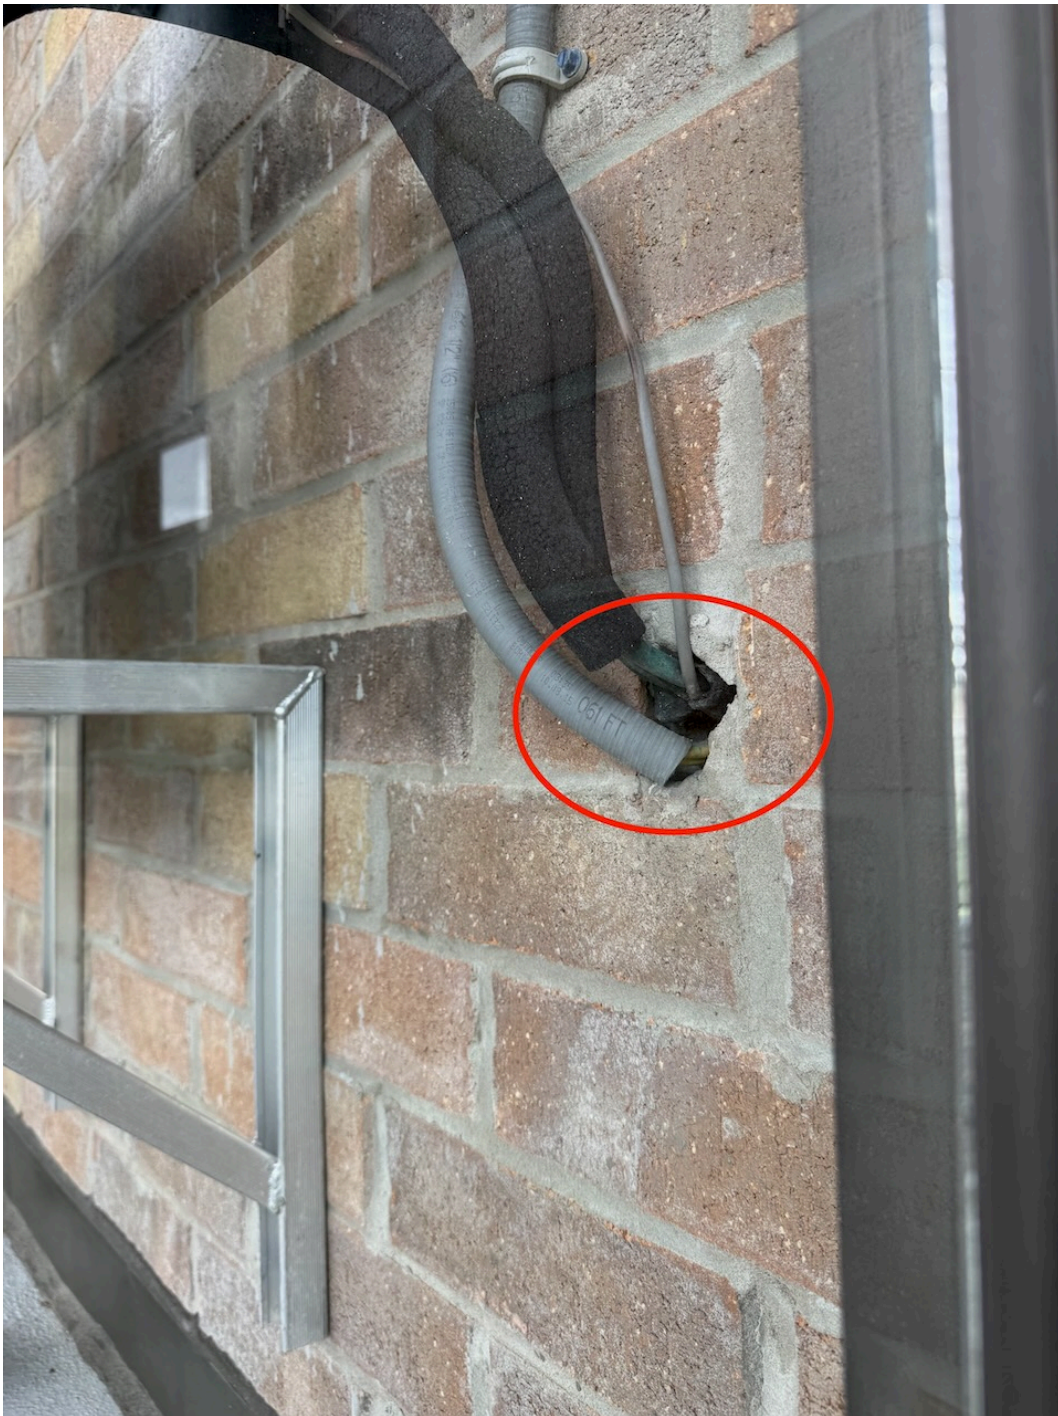
Photo 48: Caulking repairs required.

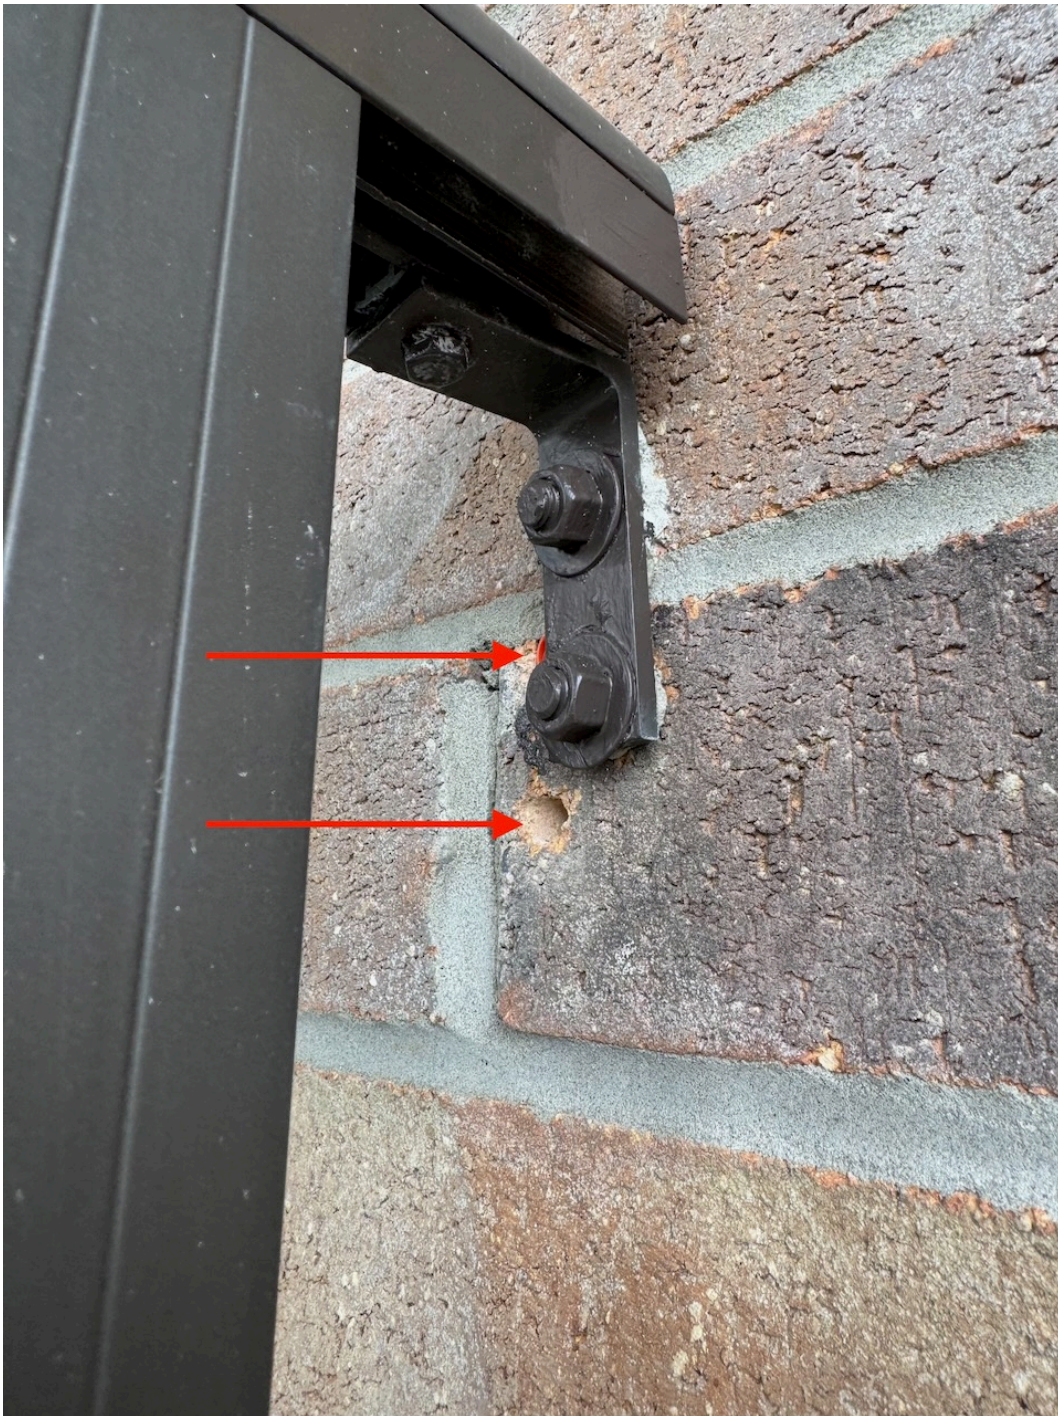
39.1 Drop 14 ('15/'13 Units): All work is now complete. BLP conducted a final review of the balconies and noted minor deficiencies to Jonas on site. These included installing caulking around the A/C lines at the building wall, on unused holes in the brick, and at an exhaust grille, paint the fastener heads on the flashing perimeter on the soffit, clean the partition at Unit 315, and minor cleaning and paint touch-ups of one section of Hardie siding at Unit 413. All other aspects of the balcony rehabilitation were in good condition. Refer to Photos 1 to 19 from April 30 interim review and Photos 20 to 48 from the final review on May 11. Refer to Photos 49 to 54 for the minor deficiencies that the contractor will have completed at this time.

Photo 49: Caulking repairs required.

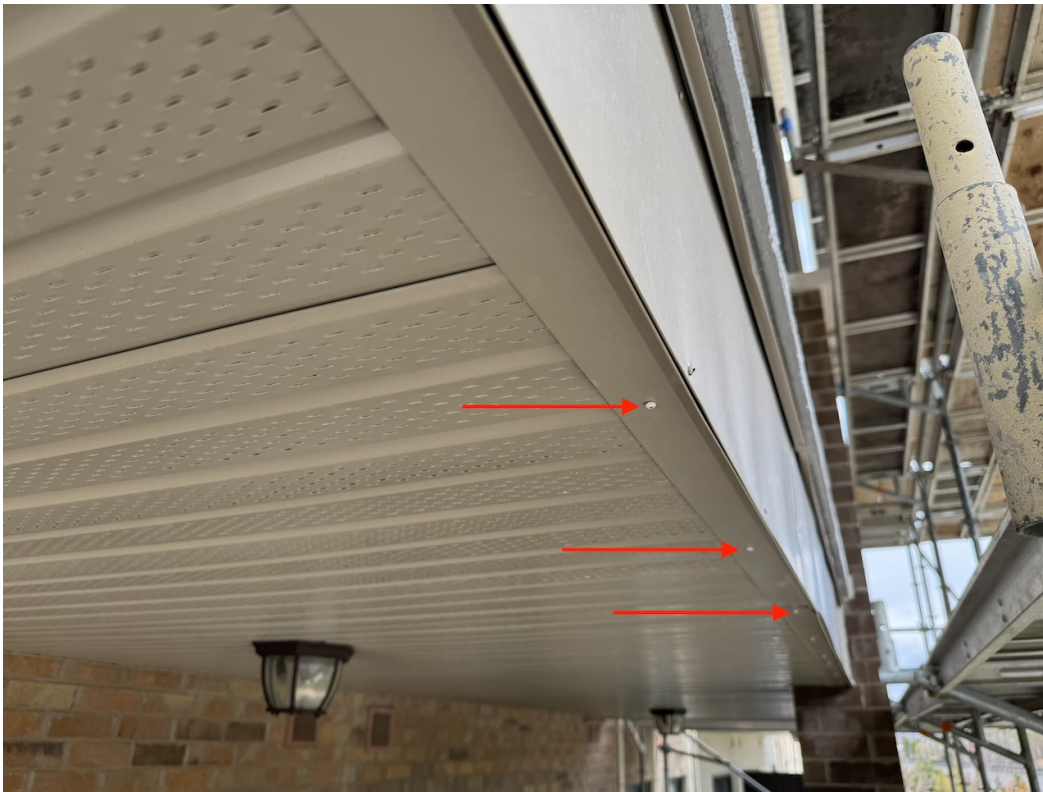
Photo 50: Paint touch-ups required.

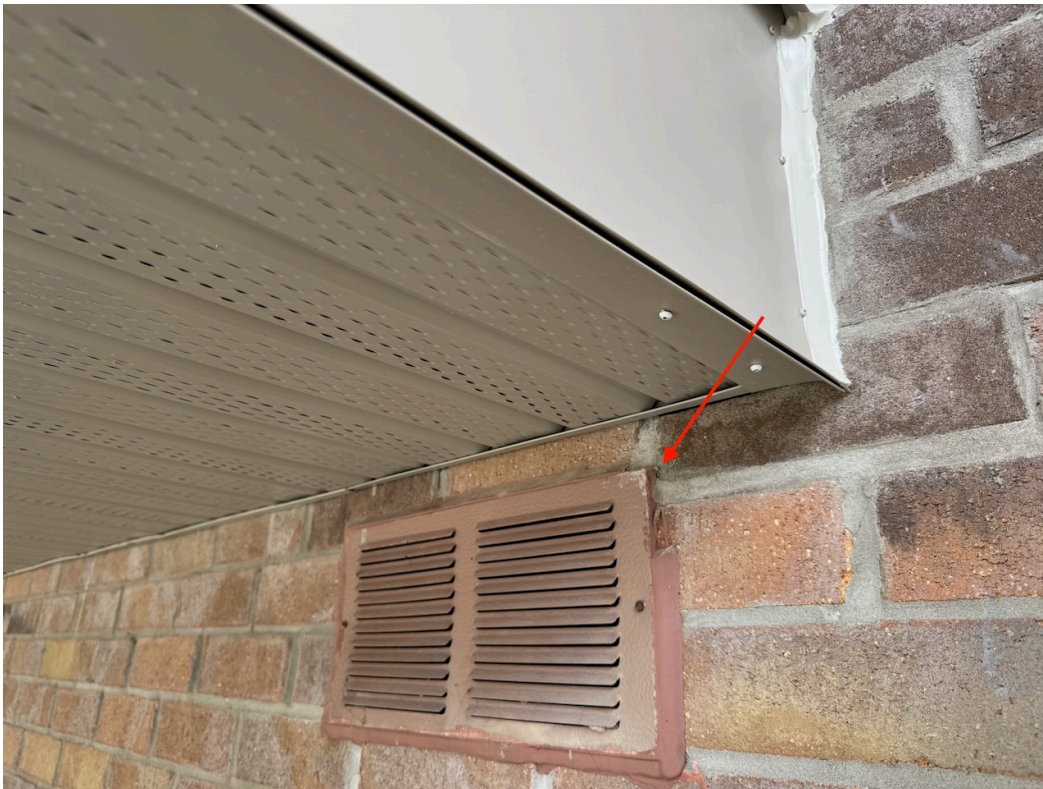
Photo 51: Caulking repairs required.

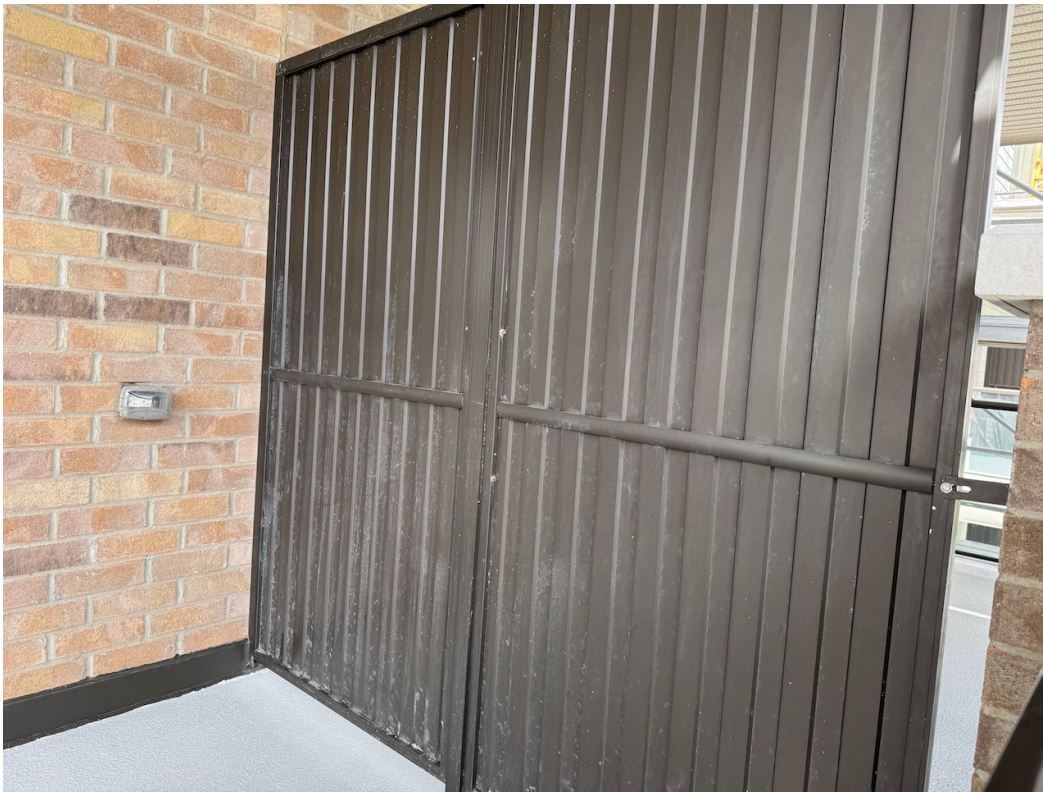
Photo 52: Clean partition.

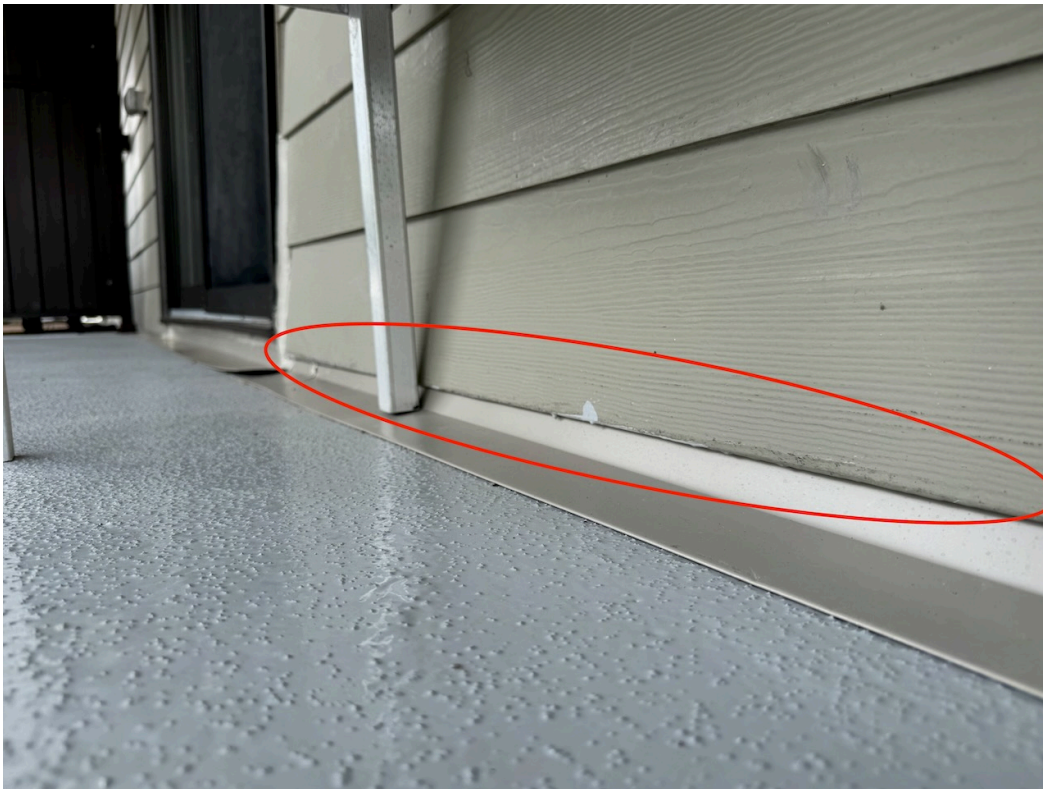
Photo 53: Clean and paint touch-ups required.
